# Moreton Conservation Area

## Appraisal document

**Adopted Document**

**October 2015**

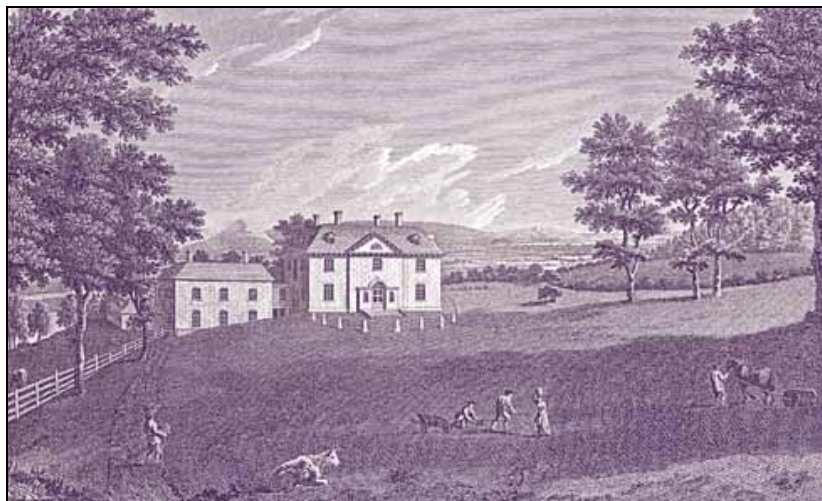
**FIG. 1:** *Moreton House c.1774. From the first edition of Hutchins. Compare with the view in FIG. 2, which shows little change. Whilst some artistic license must be allowed for, details such as the subdivision of the parkland with post and rail fencing and the generally open backdrop are of some interest in understanding past landscape character and management.*

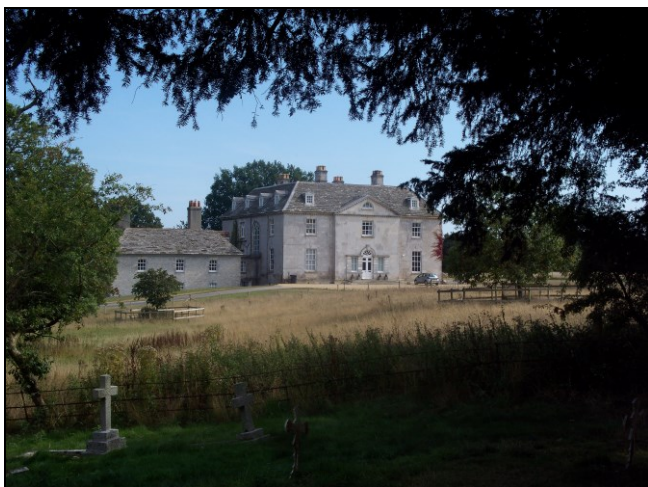
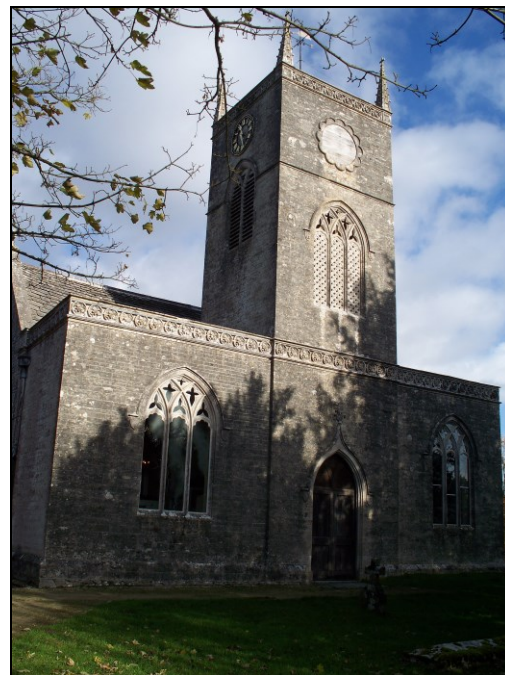
**FIG. 2:** *Moreton House and the parish church. Together with the obelisk on Fir Hill, key elements of the eighteenth century landscape design.*

48. The visual relationship of Moreton House with the parish church (see FIG. 2) and obelisk on Fir House (see FIG. 9) are of particular importance in terms of the character of the eighteenth century design and layout of Zone 4. Views of Moreton House along these axes are likewise outstanding.
49. A particular highlight of the conservation area for summer visitors to the village is the ford across a remarkably broad, but shallow section of the Frome, crossed by a long narrow footbridge. Reflections in the river surface add to the quality of the scene (FIG. 9 below).

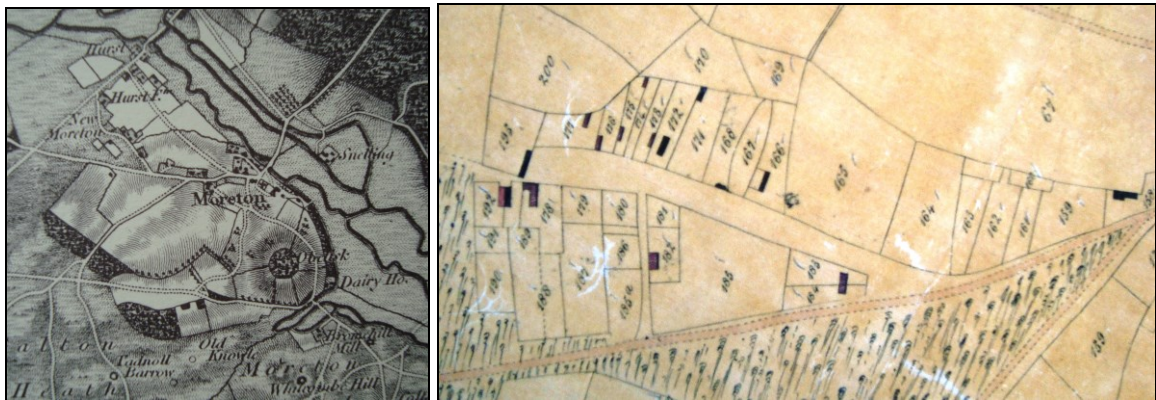
**FIG. 3: 'New Moreton'.** Left 1811 1<sup>st</sup> Ed. OS (old series) shows the village and park carved from heathland. Note 'New Moreton'. Right: 1839 Tithe Map shows cottages at The Common (T/MTN courtesy of Dorset History Centre). Note the orientation of buildings and location within linear enclosures. The lane to Hurst Farm linking to Station Road to The Common was added by 1889, and The Common itself adopted its current form by 1902.

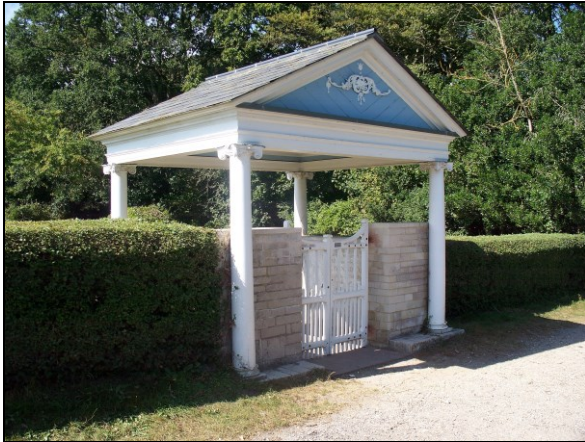
**FIG. 4:** *Classically styled gate to the new cemetery. Originally constructed c.1800 as entrance to the kitchen garden, and moved here c.1950. The modern brick walls either side incorporate panels taken from the obelisk on Fir Hill.*

28. Around 1800 a classically styled gate was commissioned to provide an entrance to the kitchen gardens (see FIG. 4 below). This survives in a much reconstructed form as the entrance to the new cemetery, and is one of the more eye catching structures in the conservation area.
29. The extent of heathland within the broader setting of the village continued to be reduced in area through enclosure, and improvement for agricultural use and plantations. The 1839 tithe map shows that at that time, and probably only for a very short period after, a finger of Moreton Heath still extended to fill the gap

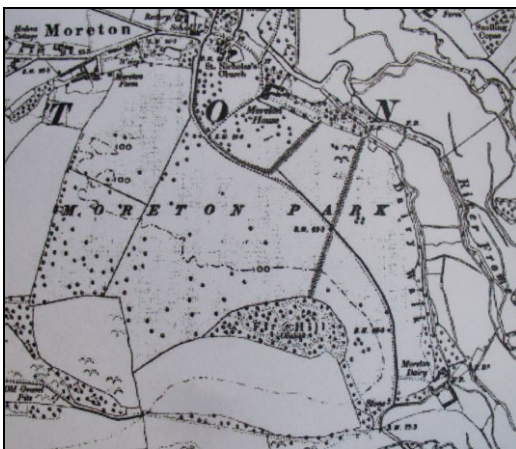
**FIG. 5:** *OS map of the 1902 showing Moreton Park. The inner park immediately adjacent to the house is distinguished from the outer park as at present, though a greater number of specimen trees are shown within the latter.*

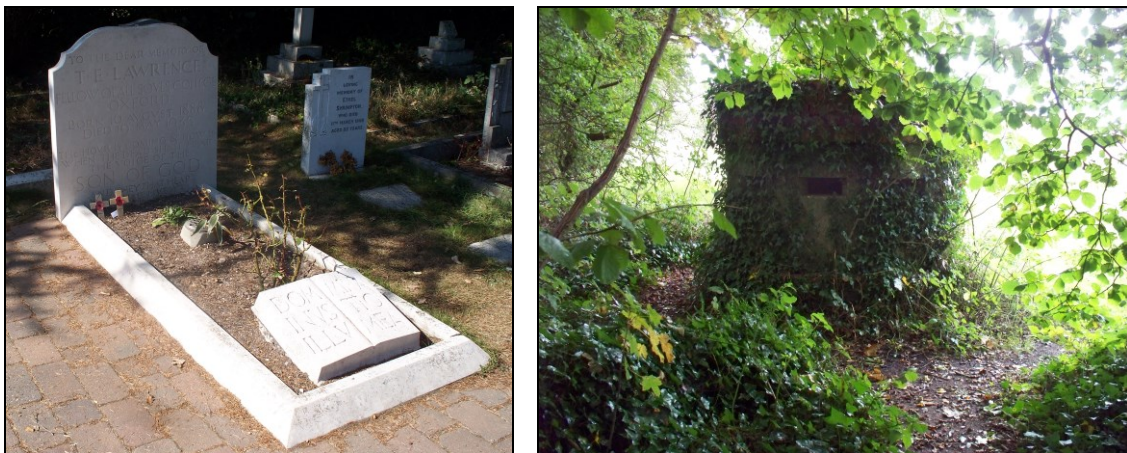
**FIG. 6:** *Twentieth century interest. Left: gravestone of T.E. Lawrence. Carving by Eric Kennington. Right: World War II pill box overlooking the Frome crossing.*

33. The burial ground appears to have been established between the wars, with the first burials here dated to the 1930s. Two features distinguish the site: the gate (see FIG. 4 above), which was relocated here around 1950, and the grave of T.E. Lawrence ('Lawrence of Arabia'), whose memorial was carved by his friend, war artist and sculptor Eric Kennington (see FIG. 6 below).

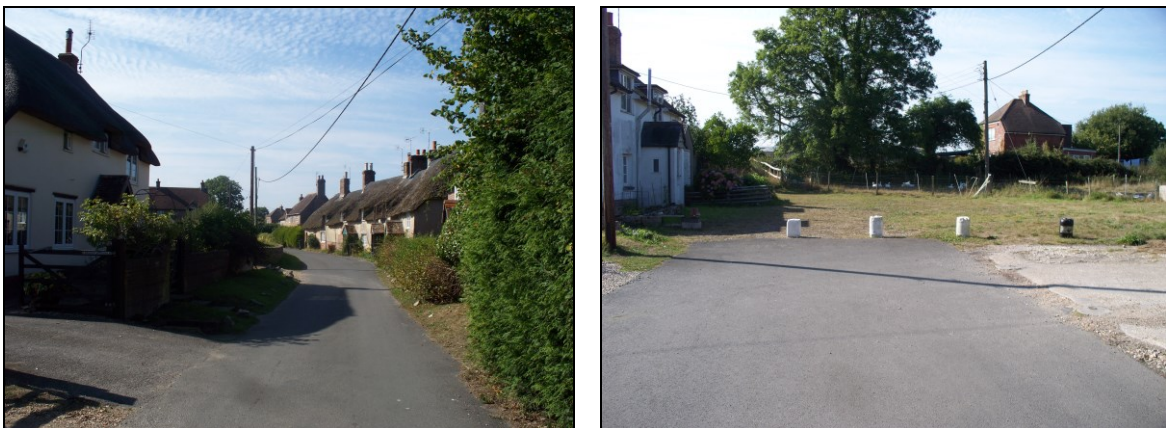
**FIG. 7:** *The Street. The road curves gently, ending abruptly with a row of plastic barrels and otherwise fizzling out into open space. The road historically continued to Glebe Farm. Note the attractive tree, one of many in the conservation area.*

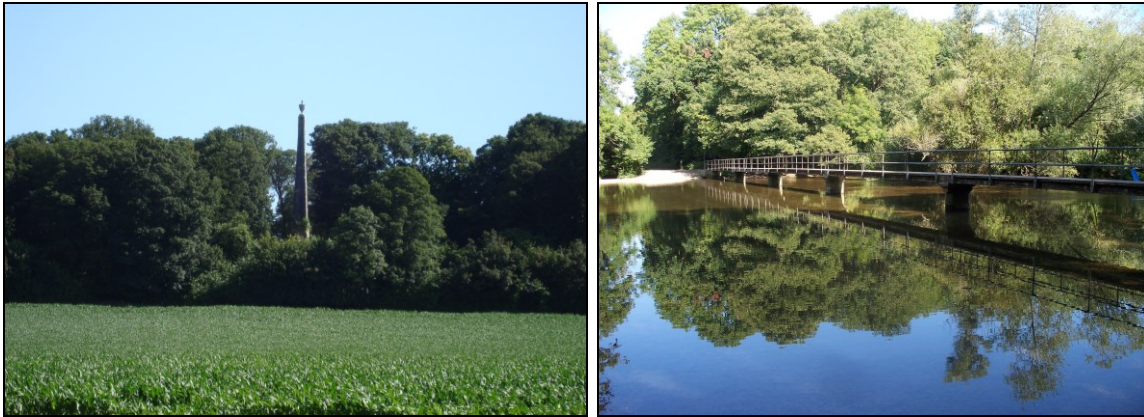
**FIG. 9:** *Visual quality. Left: The obelisk, viewed across Moreton Park. Right: Bridge on the Frome. The pill box shown in FIG. 6 stands on the bank in the undergrowth to the left of shot.*

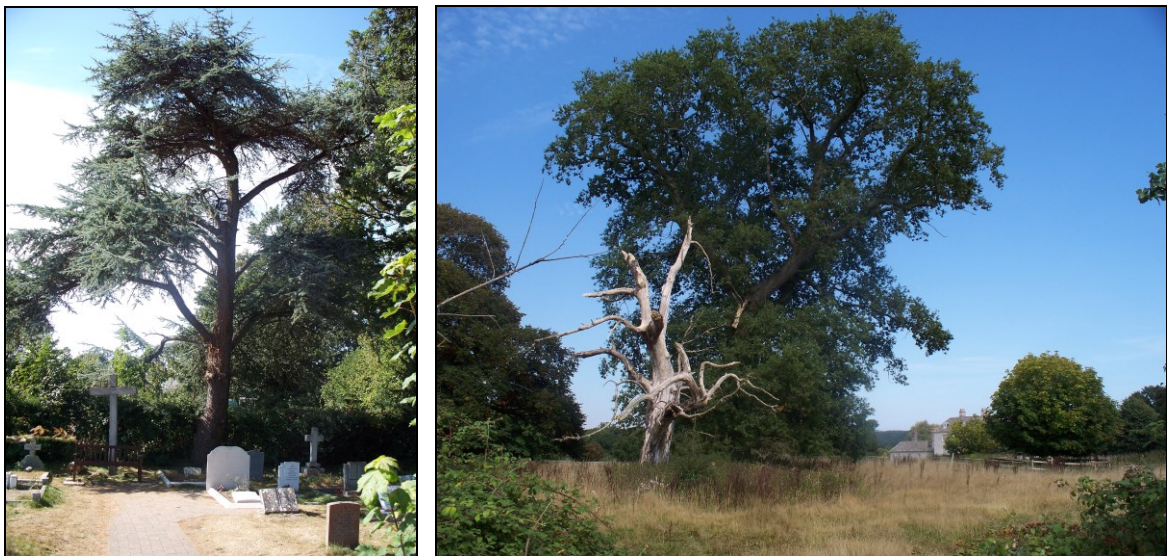
**FIG. 10:** *Notable trees. Left: pine tree standing behind the gravestone of TE Lawrence. Right: mature oak and dead tree in Moreton Park.*

and on Fir Hill. More ornamental planting is visible within Moreton Gardens, and this helps to provide a canopy over the road entering the village from south. Notable trees occurring outside the groups noted above include the large holm oaks and beech trees at the entrance to Glebe House which stand prominently at the fork of Station and Hurst Roads, and a rugged pine which provides an attractive back drop to the gravestone of TE Lawrence (see FIG. 10 below).

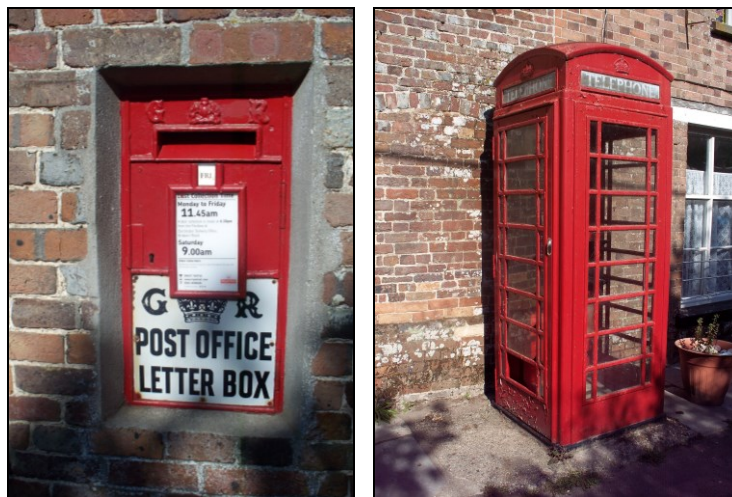
**FIG. 11:** Letter box and telephone kiosk. Archetypal twentieth century street furniture. The enamel plaque lends interest to the post box, whilst the kiosk would benefit from renovation which might in turn encourage its use.

57. A red K6 telephone kiosk stands adjacent to the old post office. This is a 'jubilee' model of 1935 design, apparently installed in 1958. Whilst the village does not have a free standing posting box, an interesting George V (1910-36) box with enamel sign is built into the wall of the old post office (see FIG. 11 below). A finger post stands adjacent to the old school, the top and possibly the centre post of which appears to be original (early twentieth century), though the fingers themselves have been replaced.

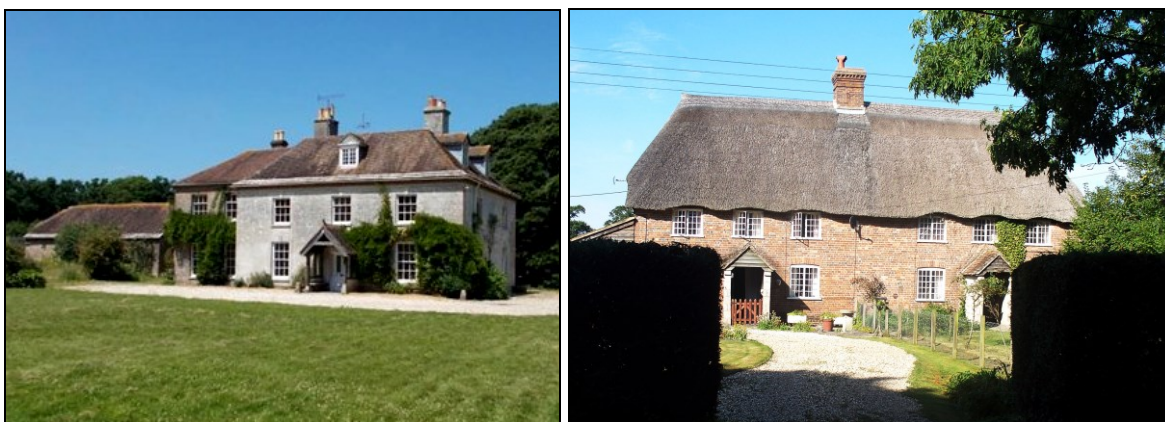
**FIG. 12:** *Style and status. Left: the Manor House. Right: Manor Farm Cottages. Both properties have a formal composition, though aside from differences in their plan form and size, fixtures and materials help to differentiate status.*

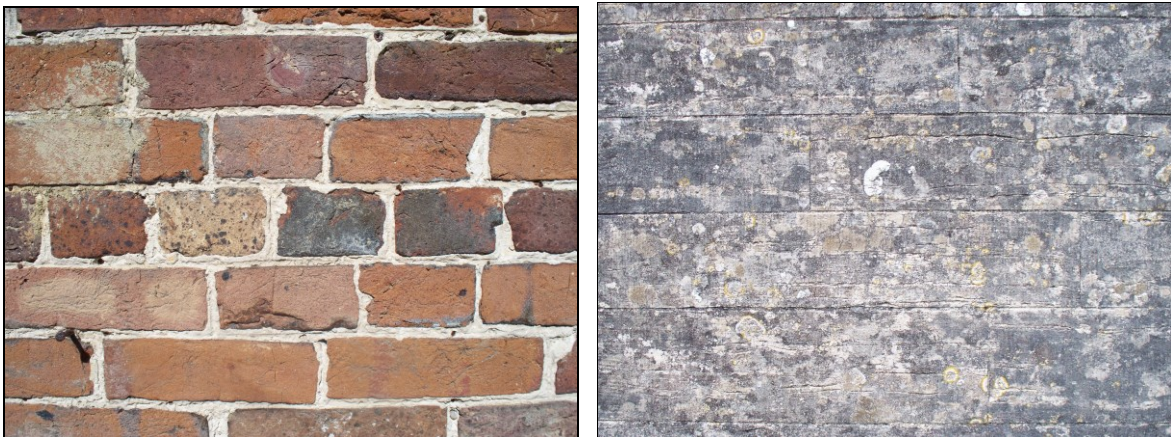
**FIG. 13:** *Typical building materials. Left: brick. Note the variations in the tone of red reflecting variable conditions during firing. Right: finely jointed blocks of Portland stone (termed 'ashlar').*

65. Use of brick is common within the conservation area. Various brickworks would have operated on the estate during the eighteenth and nineteenth centuries, and are likely to have provided the bricks used within the conservation area. Amongst these, a brick kiln is known to have existed in Oker's Wood in 1770, and brickworks were established in Briantspuddle and at Blackhill in Turnerspuddle during the nineteenth century. Whilst the village itself lies entirely upon deposits of the Poole Formation, all the above brickworks made use of Reading clay. Around much of the conservation area brick has been obscured by heavy lichen growth (see FIG. 17), but where visible the colour tends to vary between medium red and purple, often with dark blotches visible within the brick (see FIG. 13 below). The latter are a typical feature of Reading clay bricks, whilst variations in the colour and quality relate to conditions during firing.

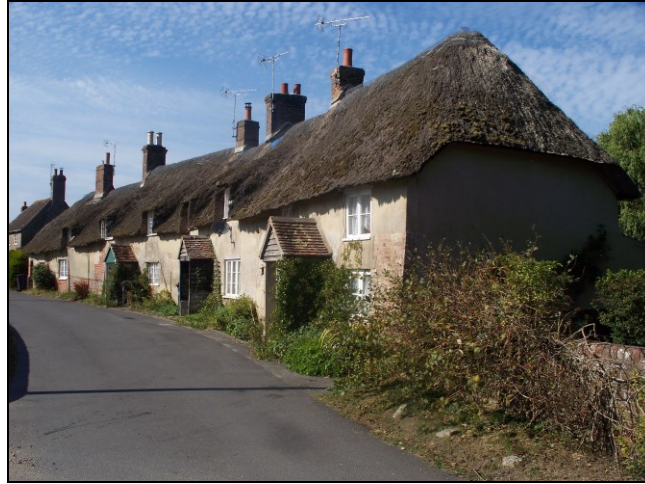
**FIG. 14:** *Thatched roofs of Nos. 2-5 The Street.*

18. It is thought that No. 4 The Street (see FIG. 14) has seventeenth century origins, though the rest of the row has been dated to the eighteenth and early nineteenth centuries, indicating incremental development which contrasts with the more formal arrangement of late eighteenth century cottages in the village.

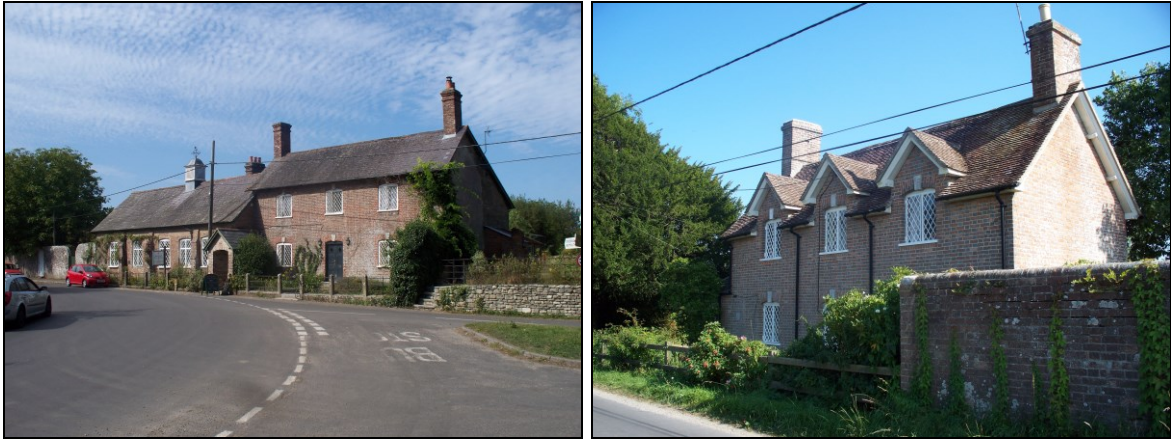
**FIG. 15:** *The old school and Garden Cottage. These two stylistically similar buildings are the most noticeable to drivers passing through the village due to their roadside positions. Note similarities in form materials and details including pitched roofs, lattice casements and arch designs.*

30. The school (FIG. 15) was present by 1839, though its fabric (exposed internally by the hacking of plaster from the walls) shows clear signs of extensive modification since construction. In 1841 the church was enlarged through addition of the north aisle, and the Bakery House and old post office are also likely to date to a similar period.
31. The Common remained the broad access shown on the 1811 map (FIG. 3 above), and most apparent on the 1889 OS, until the south western hedge line was added 1891-1902. The surviving open space between Beehive Cottage and Nursery Farm, and the open site on which the village hall stands recalls the former character and dimension of the lane. Laburnam Cottage, Oaktree Cottage, Acryse and its neighbour were all present by 1889.

74. As is typically the case, window type tends to vary according to the status and style of the historic buildings concerned. Vertically sliding timber sash windows occur within those buildings in the village of higher status, whilst casements in either steel or timber, occur in those of lower status. The latticework casements of the old school and Garden Cottage are a notable feature of these two stylistically similar buildings (see FIG. 15 below).

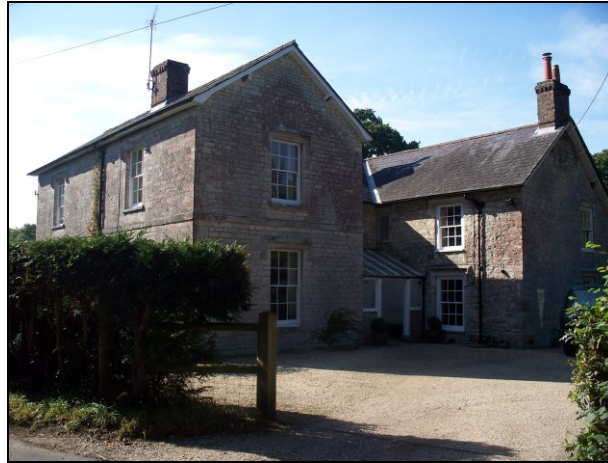
**FIG. 16:** *Manor Farm. The original house is the range to the right, and probably dates to the early nineteenth century. The range to the left and centre is a large extension probably added later that century. The quality of construction and retention of many original windows is notable. Reflecting the different dates of the two parts of the property, the windows on the older range have exposed sash boxes, whilst those on the later range are recessed.*

- 
- *Manor Farm*: An attractive farmhouse which appears to have been built in two phases during the nineteenth century on land that was previously part of Moreton Heath (see FIG. 16 below).

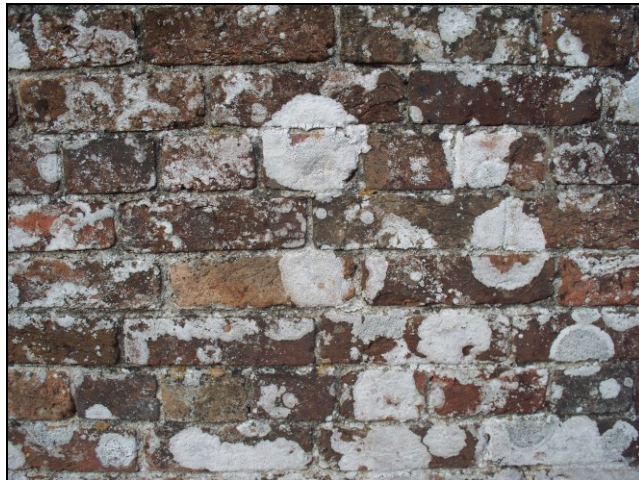
**FIG. 17:** *Lichen on brickwork along Station Road.*

81. The visual character of the conservation area is considerably softened by growth of lichens (see FIGs. 13 and 17) which in places entirely covers brick surfaces.
