Studland Conservation Area Appraisal Document

Adopted Document

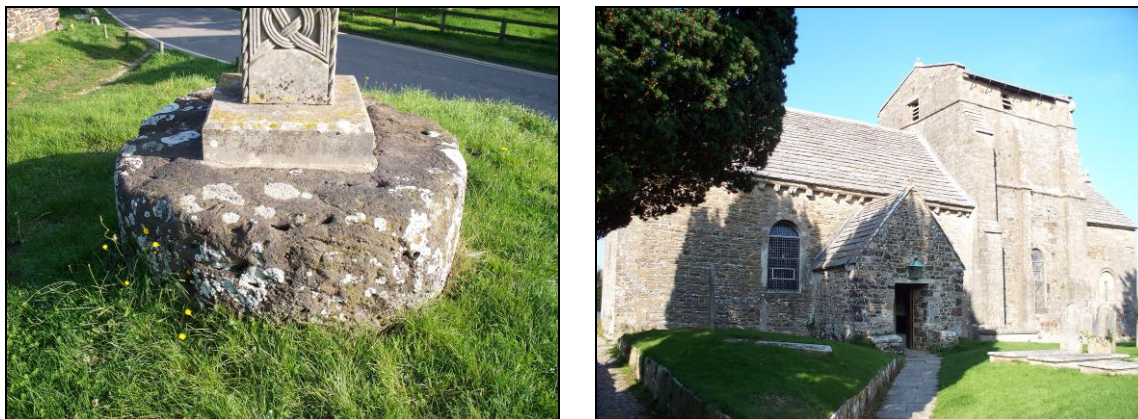
The settlement name finds origin in the grazing of horses at the location, a use which continues within the conservation area. The village contains one of the most interesting parish churches in the District (FIG. 1) which retains Saxon fabric and is otherwise substantially Norman in build. The front cover of this report shows a figure from the corbel table. The base of the village cross is also reputedly of Saxon origin, though the cross itself is modern (see FIG. 1).

FIG. 1: *Ancient fabric. Left: Saxon cross base. Right: St. Nicholas'.*

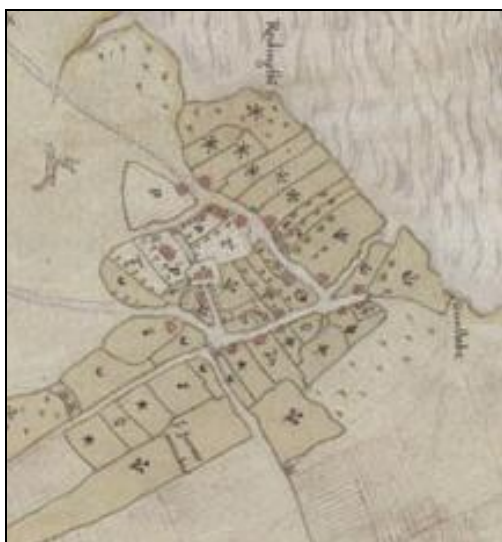
Ralph Treswell's seventeenth century map of the Studland area (FIG. 2) perhaps provides the best guide as to the character of the settlement through much of this period up until the of production. The village standing within an open expanse of what is presumably heathland with open field systems laid out to the south. The basic loop of lanes which continue to define the layout are visible though buildings show a somewhat more regular distribution around the core than they do today. Perhaps the only domestic building now remaining from Treswell's day is 11 School Lane.

FIG. 2: *Seventeenth century Studland. As depicted on Ralph Treswell's map. Note open fields to the south and unenclosed heathland to the northwest populated by deer.*

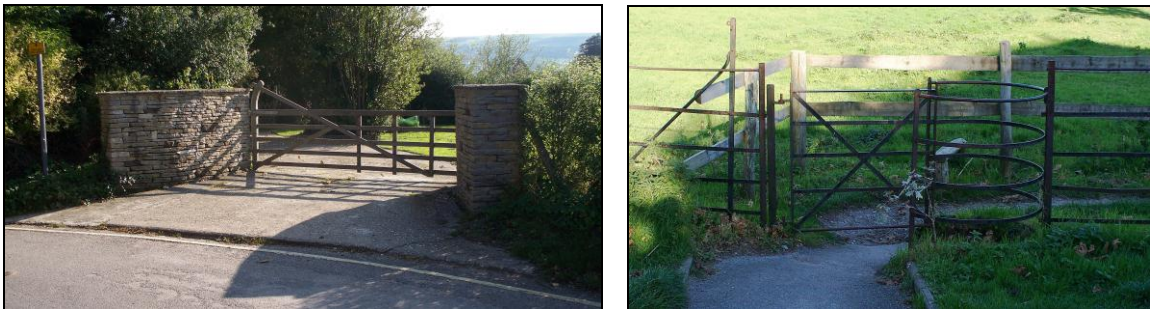
FIG. 4: Gates. Left: 'ranch' style gate. Note the yellow line and ubiquitous parking control sign. Right: kissing gate set between estate railings in the churchyard.

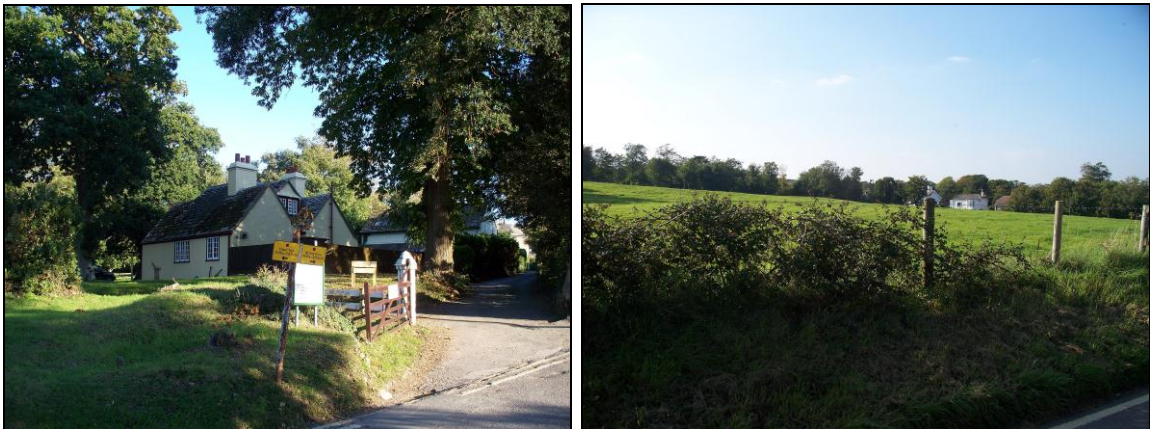
FIG. 5: *Contribution of trees and green space. Left: Sweet chestnut trees frame Pippin Cottage. A skewed parking restriction sign spoils the shot. Right: View northwest across a green space which both forms a setting for the Manor House Hotel and fills the loop formed by Rectory Road, Manor Road and Beach Road.*

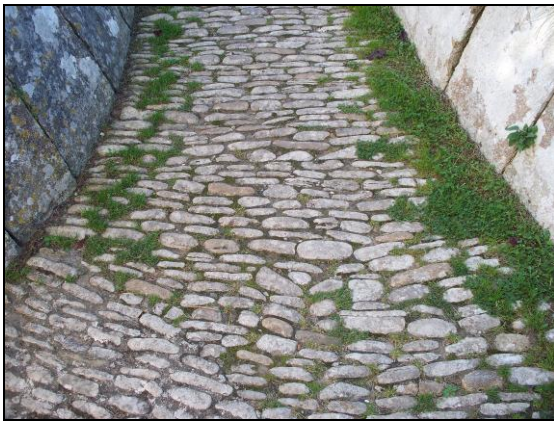
context. Paths in the immediate vicinity of the church (FIG. 6) represent an exception, these carrying a surface made up thin, irregularly sized pieces of stone pressed into the ground. The edges of the stones are well rounded which may result either from a prolonged period of wear, or collection from the beach.

FIG. 6: Churchyard paving. The stone slab revetment of the banks either side is also interesting.

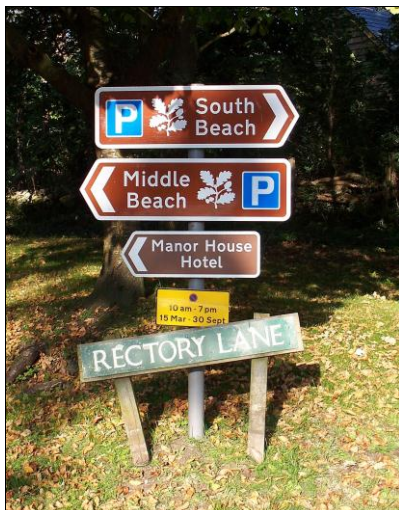
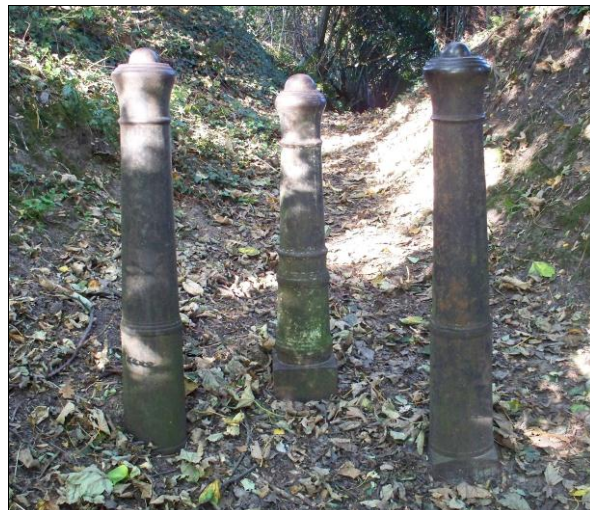
Traditional items of street furniture include a pillar box and a K6 phone box which stand on Swanage Road. The conservation area contains a large quantity of signage, both formal and informal. Yellow parking restriction signs familiar in town centres are a frequent feature on lane edges around the conservation area reflecting visitor pressure during the summer months (see FIGs. 4, 5, 7 and 13). These are unavoidably intrusive in the rural context. At certain points signage has been effectively clustered reducing possible clutter, though many 'loose' signs, particularly belonging to the hotel and pub, still occur. Street name plates are made of an undistinguished plastic material, the decaying wooden posts to which these have been attached leaving a generally poor impression.

FIG. 7: Street furniture. Left: signage cluster. Note the yellow parking restriction sign which occurs with great regularity around the conservation area, and the plastic street name plate on rickety timber post. Right: cluster of cast iron canon bollards on the track between School Lane and the churchyard.

The particularly unusual occurrence of three canon bollards set in the ground midway along the track between School Lane and the churchyard is of interest (see FIG. 7). The three don't match and the context is odd suggesting they represent an ad hoc local response to a problem.

Improve street name signs: There is significant scope to improve the current situation through use of more sympathetic materials for signage, and replacement of the posts upon which they are mounted.

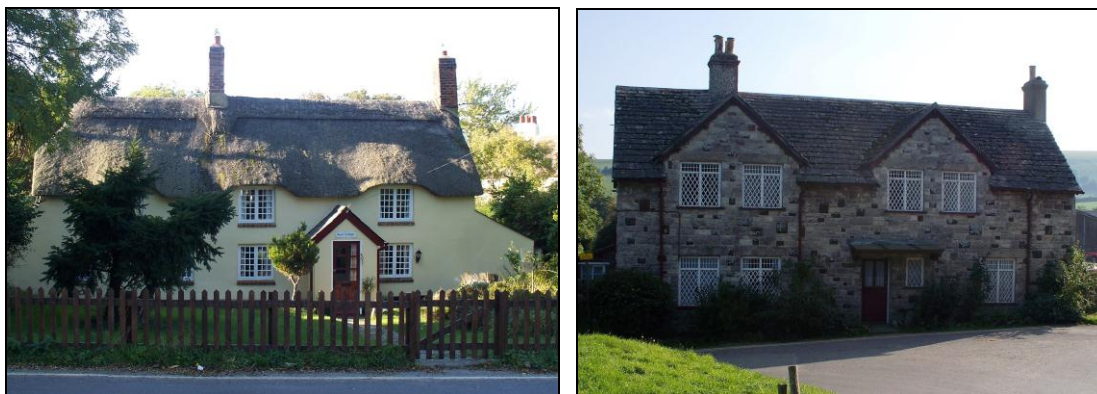
FIG. 8: *Visions of the vernacular. Top left: Beach Cottage, eighteenth century thatch and cob vernacular. Top right: Manor Farm, an Edwardian interpretation of the stone vernacular. Below: The manor, a nineteenth century Gothic fantasy.*

Cob may be considered one of the key vernacular construction materials within the settlement and is employed in the construction of a number of historic buildings (e.g. Beach Cottage – see FIG. 8), where it is finished with render.

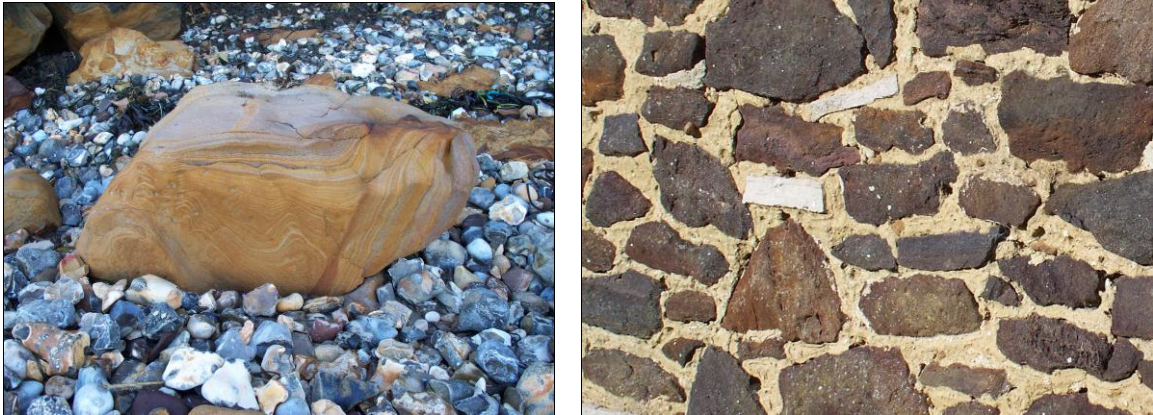
Buildings representative of the historic vernacular show use of heathstone (FIG. 9) – an iron cemented sandstone found within the Poole Formation – otherwise known as ‘Redend Sandstone’ after Redend Point, where it outcrops.

FIG. 9: Redend sandstone. Left: a piece of water worn raw material on the beach at Redend Point. Right: used as very coarse random rubble.

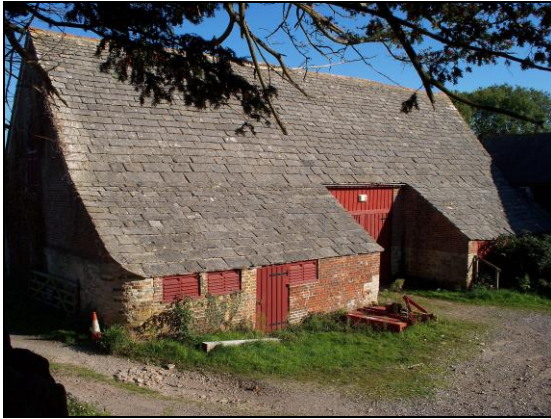
FIG. 10: *Stone roofed barn. The barn is a prominent feature adjacent to the church opposite Church Farm Cottage.*

Purbeck stone is used to roof the church – something which may be generally anticipated for such structures given the historic superiority of the material – however its frequent use in domestic and other buildings elsewhere in the conservation area is likely to reflect more the boom in production around Swanage during the late eighteenth and nineteenth centuries than a long historic tradition of usage in Studland. The swept roof of the barn opposite Manor Farm Cottage (FIG. 10) is particularly impressive, and the more so for lack of ‘pointing’.

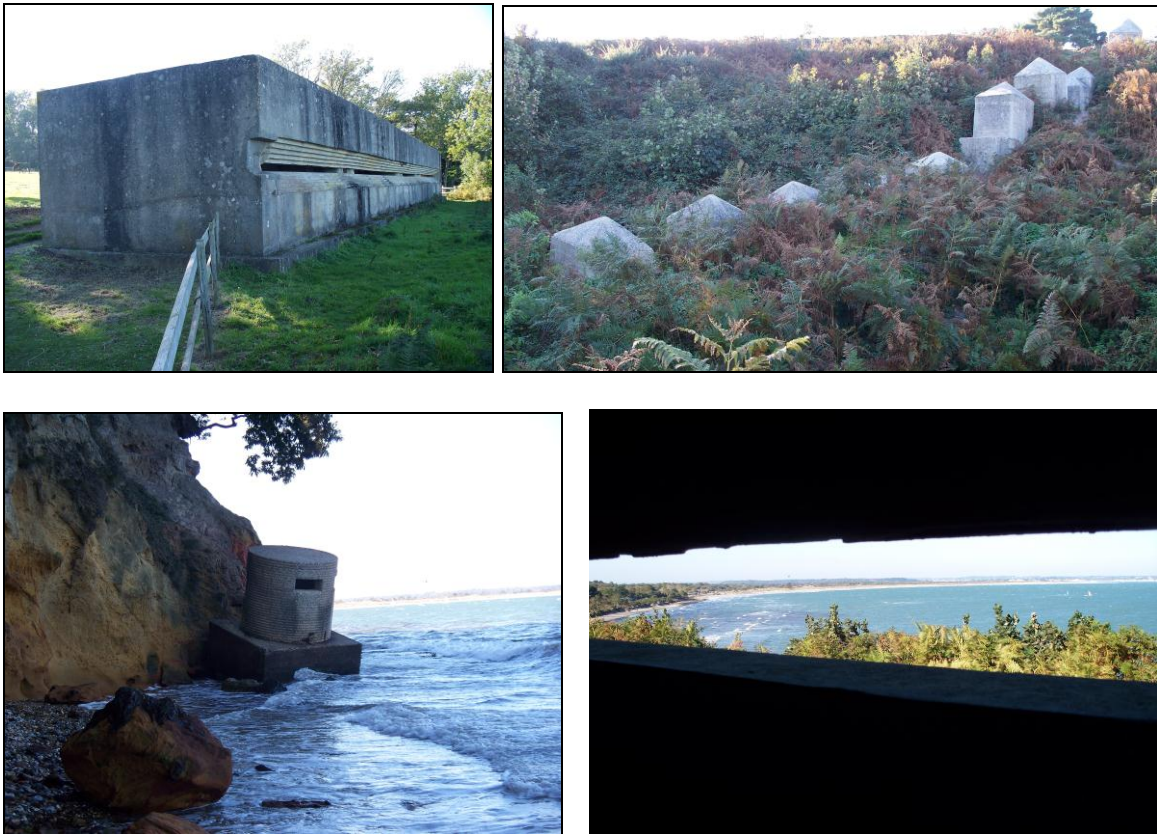
- *Fort Henry:* (FIG. 11) a large concrete fortification sitting above bunkers constructed in 1943. A number of internal compartments are served by a long horizontal recessed gun/observation slit giving a broad view of the bay. Used

- by Allied commanders in 1944 to observe Operation Smash – the practice landings on Studland Beach in preparation for D-Day.
- *Dragon's teeth*: (FIG. 11) an intact stretch of Second World War anti-tank defences arranged across the mouth of a coombe at the northern tip of the conservation area just above the beach.
 - *Pill box, Redend Point*: (FIG. 11) a small cylindrical concrete fortification now sat at a jaunty angle right on the Point. Similar pill boxes can be found at various points along the coastline of the District including at Swanage.
 - *The old school, School Lane*: Built 1845 and closed in 1947.

FIG. 11: *Relics of the Second World War. Top left: Fort Henry. Top right: anti-tank dragon's teeth. Bottom left: pill box at Redend Point. Bottom right: view across the bay from the gun slit of Fort Henry.*

Whilst sea level rise poses a threat to Studland Bay in general it poses a particular problem for the pillbox at Redend Point which already sits askew on its base. It seems unlikely that the structure will survive long term. The dragon's tooth tank defence has clearly suffered from some movement with many of the individual teeth no longer fully upright. Future erosion of the slopes upon which they are mounted may cause further movement. There are no other buildings or structures which appear from external inspection to be obviously at risk of demise or decline.

A small sliver of land is proposed for addition at the northern tip of the conservation area in order to fully incorporate the World War II coastal dragon tooth tank defences present here (pictured in FIG. 11) within the boundary.

Potential listing: Fort Henry has considerable historic value due to its connection with Exercise Smash, and is otherwise a particularly interesting and well preserved piece of military architecture. An application should be made to English heritage to list it.

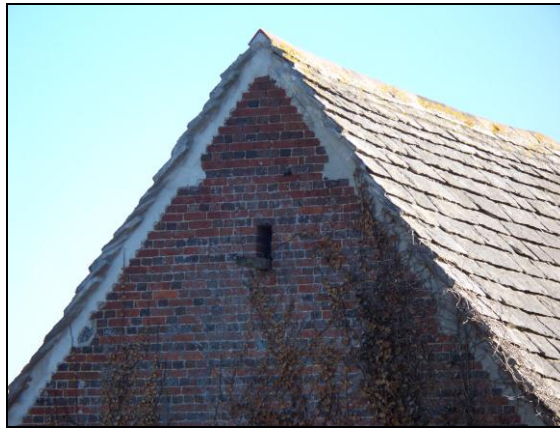
FIG. 12: *Barn owl nesting slot and perch. Seen in the end gable of the barn opposite Manor Farm Cottage.*

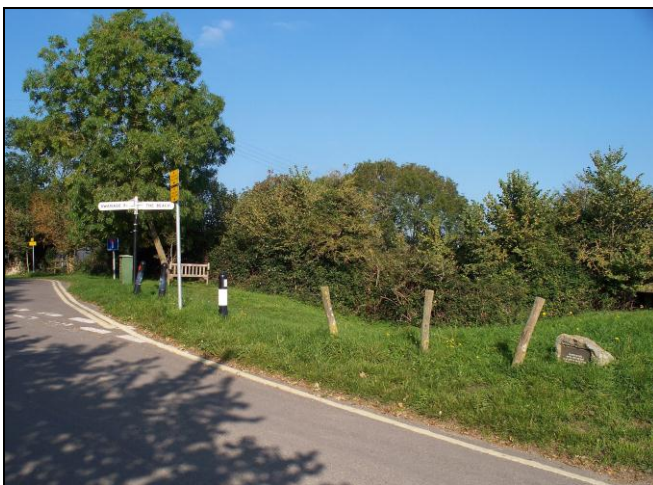
FIG. 13: *General clutter. Not one part of the verge pictured above and lying adjacent to the cross is free from one object or another.*

Declutter: A reduction in the amount of direction, restriction and advertisement signage would be beneficial, whilst at other locations (e.g. see FIG. 13) a general reduction in the rationalisation of items placed within the public realm would improve the character of the conservation area.
