# Wareham Conservation Area Appraisal Document

**Adopted Document**

**January 2012**

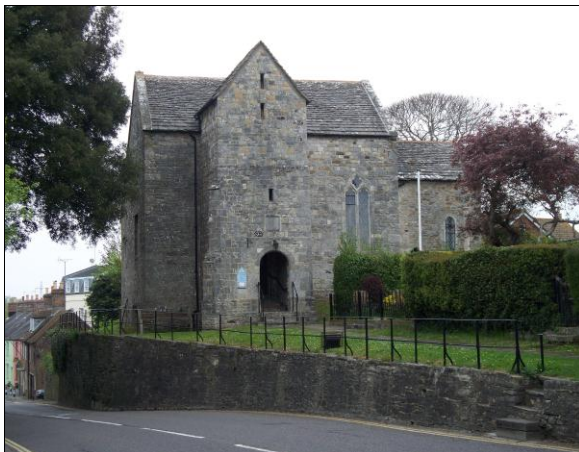
**FIG. 1:** *St. Martin's Church. The oldest building in Wareham standing high above the town's former northern gate (or 'port').*

St Martin's, the oldest surviving structure in the town, substantially dates to this period (FIG. 1). A good example of a small parish church, construction may have been a response to population expansion though the position detached from the core of the settlement above the north gate may also reflect a symbolic motive.

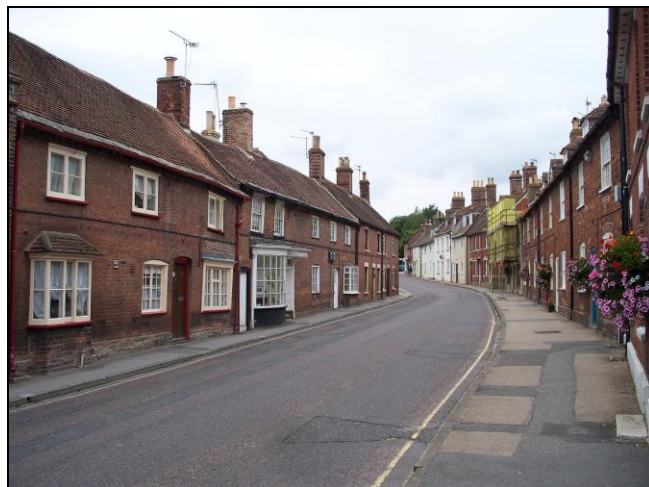
**FIG. 2:** *The castle ditch recalled. The curve of West Street, merging into Trinity Lane recalls the line of the castle's outer bailey ditch. Note the visual interest this provides as buildings climb up the slope.*

The key event of the years following the Norman Conquest was the establishment of a castle in the south western quadrant of the town. The recorded destruction of almost half the dwellings of the town described in the 1086 Domesday Book may relate to this event. The impact is still clearly evident in topography and street layout, the motte substantially intact and echoes of the inner and outer bailey ditches reflected in the routes of Pound Lane, Trinity Lane and in the gentle curve of the top end of West Street (see FIG. 2).

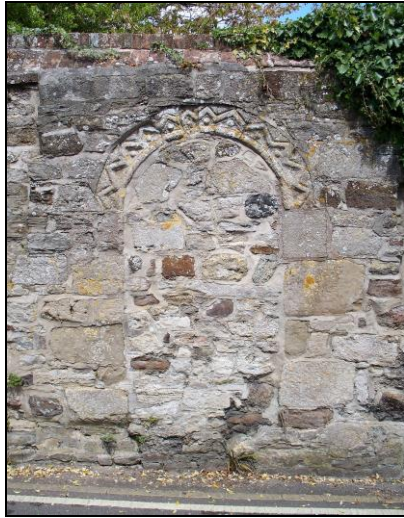
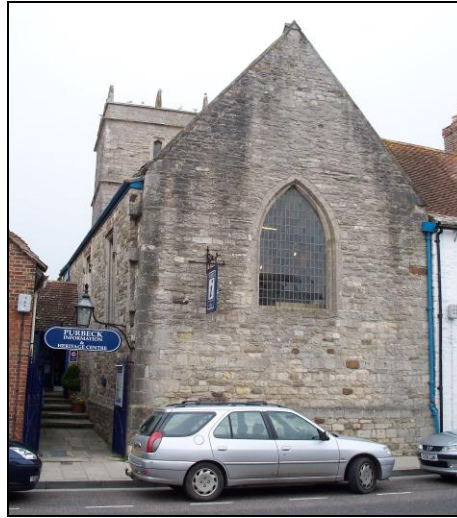
**FIG. 3:** Medieval fabric. Left: an arched doorway built into the wall of the Old Rectory, Pound Lane; thought to be derived from the castle. Right: former Holy Trinity Church with fourteenth century nave; sole survivor of several small churches built in Wareham during the medieval period.

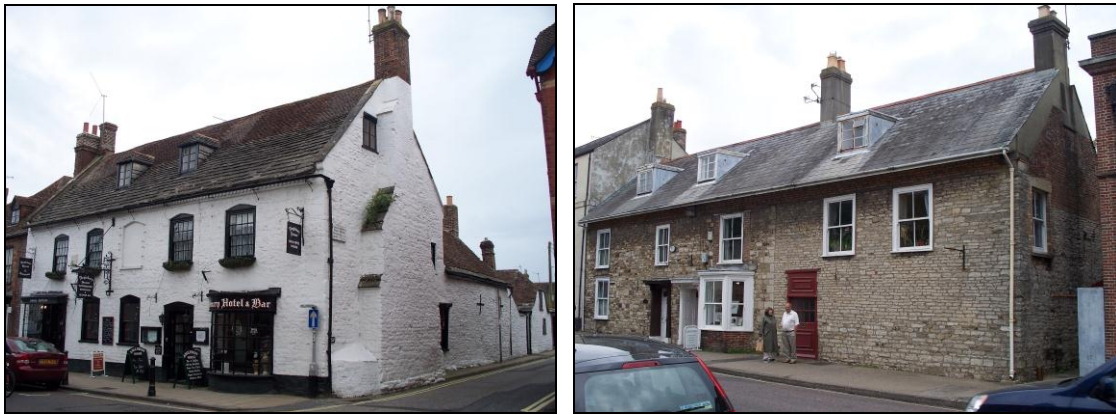
**FIG. 4:** Buildings of the seventeenth century. Left: 15-17 North Street. Right: 14/14a North Street. It seems likely that the whole of the roof of 15-17 was covered with stone originally, while the slate on 14/14a represents one nineteenth century alteration amongst others (render has clearly been removed from the frontage).

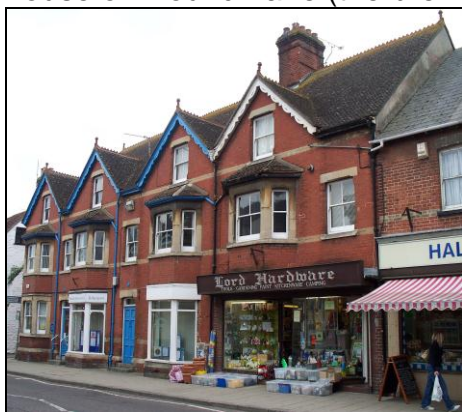
**FIG. 6:** *Late nineteenth century development. A feature most frequent in North Street. The terrace pictured in part replaced the medieval All Hallow's Chapel which stood at the junction with Cow Lane.*

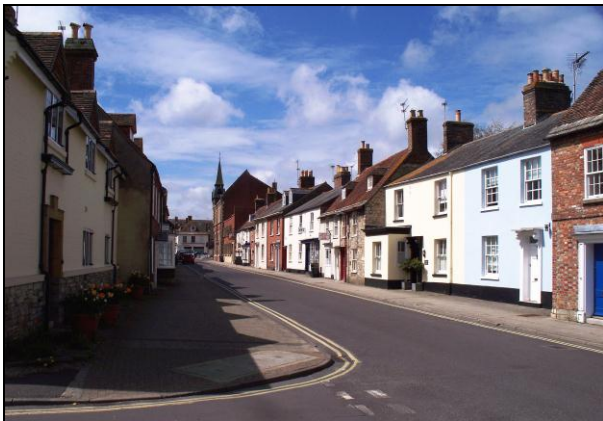
**FIG. 7:** *East Street viewed toward the centre. Of primarily residential character (though with evidence of former shops) with generally similar ridge heights though with some variation in pitches between slated and tiled roofs. The frontage breaks up further east reflecting the historically sparse pattern of development here.*

Pitches vary (see FIG. 7), with some tiled roofs reaching pitches much steeper than the norm (e.g. 20 West Street). Roofs built to be slated may naturally be found at low pitches though again variation is seen given its sometime use as a substitute roofing material.

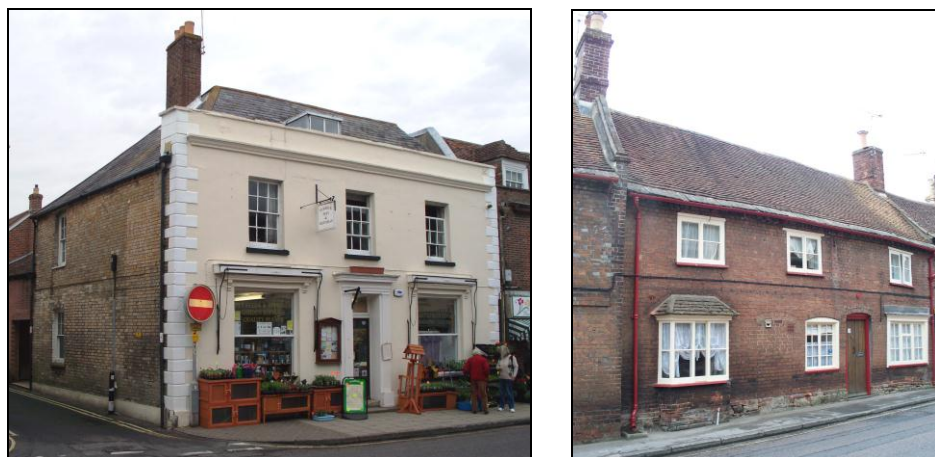
**FIG. 8:** *Class differences. The contrast between Nos. 8 (left) and No 39 (left) West Street is clearly expressed in terms of stature, massing and ornament. Façade emphasis differs with strong vertical emphasis displayed left, and horizontal right, which reflects fenestration type.*

The substantial rebuilding of the core of Wareham during the late eighteenth century and relatively limited redevelopment since this time has given Zone 1 a predominantly 'Georgian' architectural character; a background against which both earlier and later buildings are usually easy to discern. In this regard North Street, as the least afflicted by fire and the most redeveloped of the main streets is the least homogenous architecturally. It is important to note that the presence of shop fronts even at the centre of the town does not represent an aspect of original architectural character, and though the earliest of these do date to the first half of the nineteenth century the majority of buildings were designed and intended to serve as dwellings. Most of the best/largest houses were located close to the centre though relatively unaltered if less pretentious outliers do still occur in the St John's Hill area (FIG. 14), parts of East Street and the upper reaches of West Street. A three bay configuration, often stuccoed, provides a common template for houses of various sizes. Details such as cornice, parapet and quoins are variously applied (see FIG. 8).

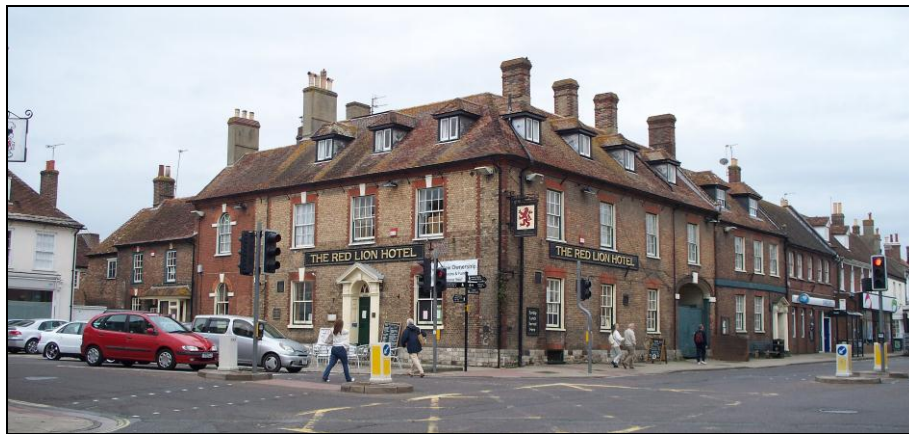
**FIG. 9:** *The Red Lion. A building with strong presence whose bulk in form is balanced by vertical emphasis in detailing and softened by hipping of roofs. The building brings important definition to the corner. The broad gap between this and the town hall was occupied by buildings providing market functions prior to the fire. The location is now dominated by traffic. Note use of buff brick.*

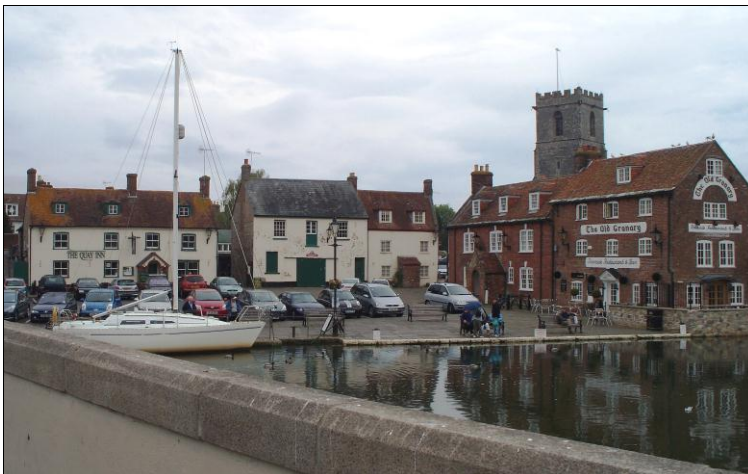
**FIG. 10:** *The Quay viewed from South Bridge. A classic view. The Old Granary formerly served as a warehouse as too the annexe to the Quay Inn (centre). As with many other spaces within Zone 1, cars dominate.*

The Quay with St.Mary’s behind as viewed from South Bridge (FIG. 10) provides a composition of particular quality spoiled a little by the elevated dining area to the rear of the Old Granary. Passage down West Street from the centre provides particular interest by virtue of the combination of a continuously enclosed street edge with changing topography and street line. The gently rising ground level and the deflection of West Street (FIG. 2) combined with narrowing street width and the abrupt transition from town houses to cottages provides visual stimulation through a varied and unfolding view. Similar visual interest is provided by the curve of Pound Lane around the Brewery House, in contrast to North, East and South Streets whose more linear nature allows views along most of their length from the centre. The prominence of St Martin’s approached from either side of the walls on North Street is an arrangement of particular and quite probably symbolic historic note.

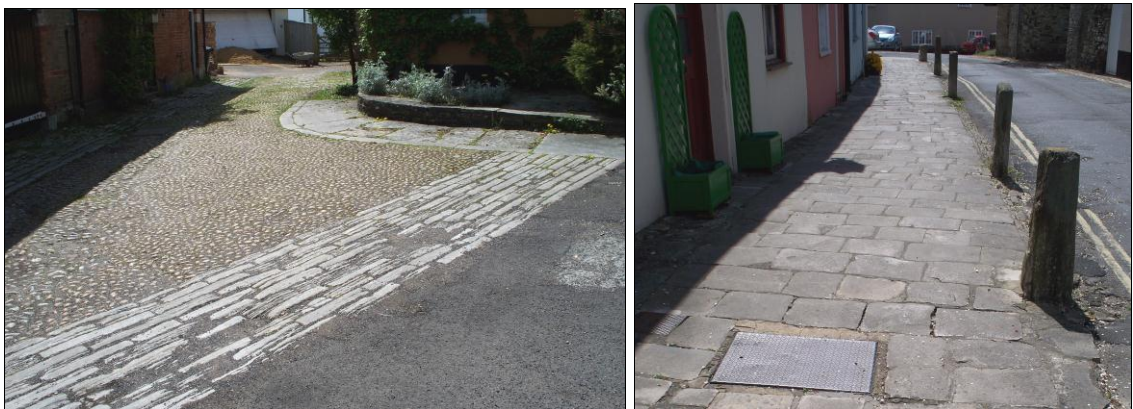
**FIG. 12:** *Historic paving schemes. Left: surfaces adjacent to the old brewery, Pound Lane. Right: paving with stone lined gutter and stone bollards between St John's Hill and Church Green. Both have been damaged by road works.*

Unusual stone bollards, some of which have been replaced with replicas or otherwise replicated, line the pavement edge between St John’s Hill and Church Green (see FIG. 12). Cast iron bollards and imitations in plastic have been installed in various locations around the town and are of entirely modern origin. These show little consistency in terms of type though mostly comprise the black and gold ‘heritage’ model (also adapted to serve cycle parking) ubiquitous of many enhancement schemes of similar vintage. Similar bins, benches and posts have also been employed, the first at least distinguished with the town emblem. The conservation area contains one particularly interesting early cast iron sign which is attached to South Bridge (FIG. 11). Similar survive on other historic bridges around the County. A painted sign prohibiting traction engines from using Cow Lane is attached to the Anglebury, though is of lesser vintage and questionable authenticity. Modern street signage is generally of standard highways type with little thought apparently given to positioning; that recently

Photographs suggest the extensive use of Purbeck stone paving in Wareham. Little now survives; this including short stretches in Pound Lane and between St John's Hill and Church Green. By at least the nineteenth century, and possibly as early as the late eighteenth century (see Hinton and Hodges) street surfaces appear to have been formed by a rammed aggregate which was watered to control dust. Latterly the water was drawn from the river using the Bamford's pump which remains on west side of the Quay (FIG. 19). On the main streets gutters appear to have been stone lined whilst stone kerbs were more widespread. Minor metalled road surfaces did also occur historically and still survive in Pound Lane (a pebble surface between buildings associated with the old brewery the corner of which has been damaged by water contractors) St John's Hill outside Seymour Place (a surface formed from slivers of stone set on edge which inspired the modern landscaping scheme on St John's Hill) and in various rear accesses viewed along Trinity Lane. Purbeck stone setts serve the arched entrance to the old brewery and similar are found mixed with rougher stone in the parking area outside the Red Lion in West Street. Recent surfaces generally utilise tarmac or concrete slabs, the latter plain or coloured.

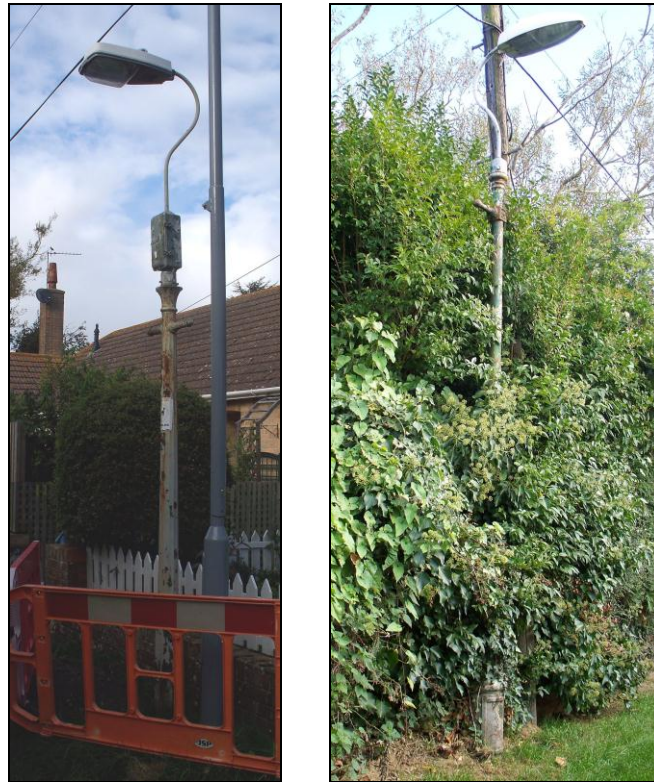
**FIG. 13:** *Historic lamp columns. Currently in Tinker's Lane though soon to be removed.*

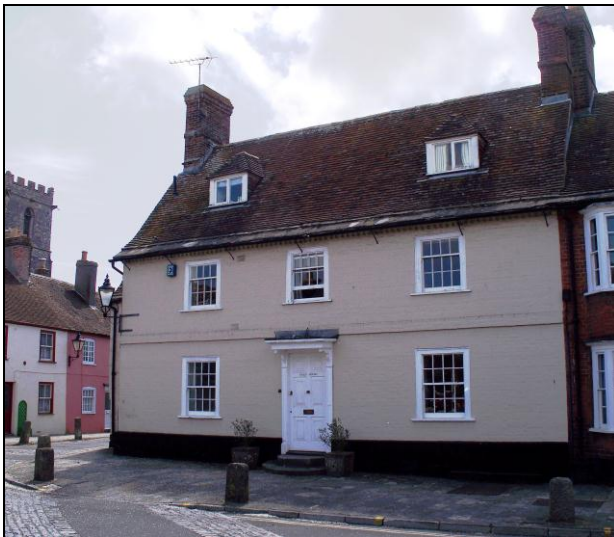
**FIG. 14:** *Three bay format. A three bay configuration expressed at varying scale is common amongst eighteenth century properties. This example in St. John's Hill displays various 'typical' features (e.g. dentil course, stone easing course, hipped dormers, bracketed canopy – multi pane sashes - though the windows appear unusually squat). A stuccoed example is shown in FIG. 8.*

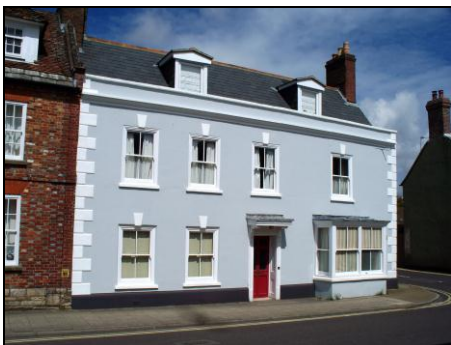
**FIG. 15:** *Stuccoed frontage. A good example of a frontage with parapet, quoins and keystone detailing, though the struck ashlar jointing is no longer very clear. The historic treatment is unlikely to have been pale blue while the bay, dormers, four pane sashes and roof covering all represent later alterations.*

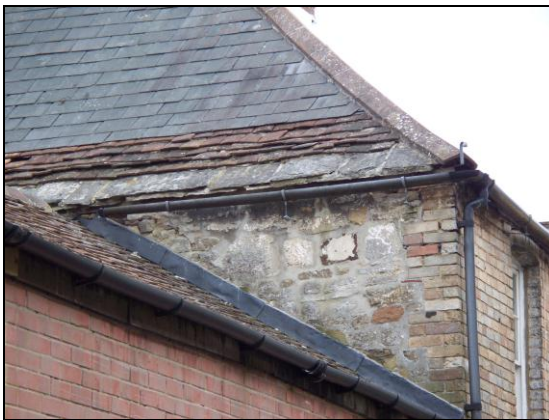
**FIG. 16:** *Material palette. The rear of 8 West Street displays a range of materials and change over time. A fragment of the original tile covering with stone eaves course survives the rest replaced by slate. A bracketed gutter has been added. Whilst the frontage (FIG 8) is stuccoed, flank and rear walls reveal brick and stone construction which might suggest incorporation of older material within the post-fire rebuild.*

Slate appears primarily a feature of nineteenth century development postdating the arrival of the railway, though in some cases has clearly replaced other roof finishes (see for example FIG. 16).

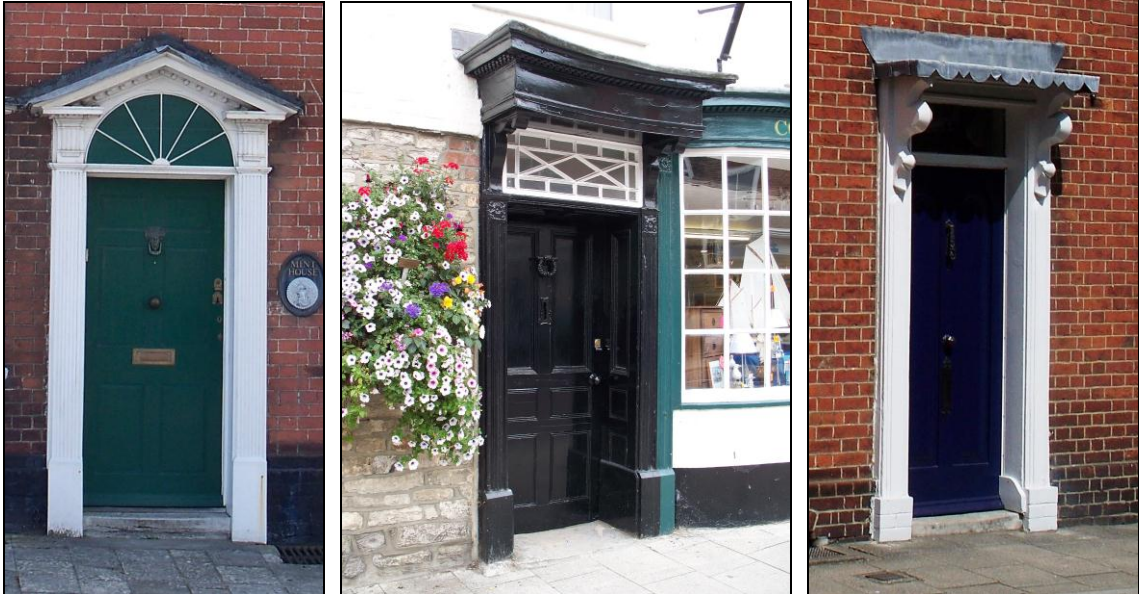
**FIG. 17:** *Door cases. Left: Pilasters with broken pediment and blind fanlight. Centre: bracketed canopy displaying a full entablature with transom light below. Right: simple flat roofed bracketed canopy with transom.*

A good collection of classical door cases survives within those parts of Zone 1 retaining a residential character. The more simple of these consist of pilasters with flat bracketed canopy perhaps oversailing a blank transom, the more ornate incorporating pediments with either blank or clear fanlights. Many such surrounds are complemented by six panelled doors though others have undergone modification or replacement by semi glazed models.

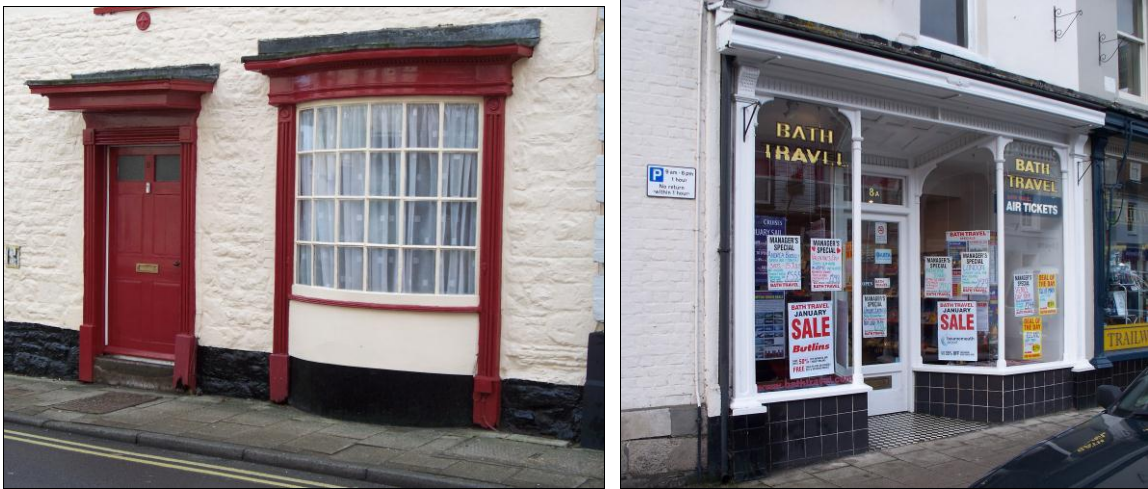
**FIG. 18:** Shop fronts. Left: early nineteenth century bow window serving a former shop at No 6 East Street. Right: Late nineteenth/early twentieth century shop front at No 8 South Street – note tiling and threshold mosaic.

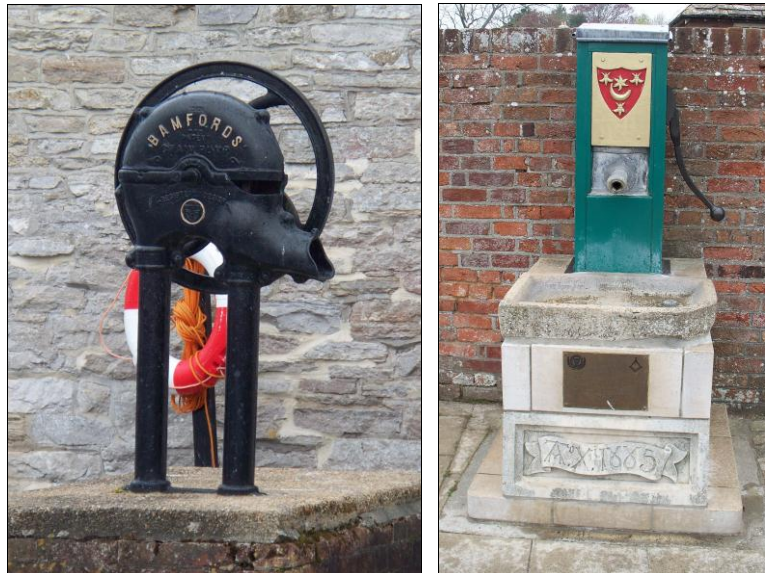
**FIG. 19:** *Pumps. Left: Bamford's pump on Abbot's Quay. Right: Water pump on South Street.*

- *Water pump, South Street:* An attractive metal pump with stone basin. No longer in its original setting or position.
- *Bamford's model 2A water pump, Abbott's Quay:* Apparently installed to draw water for sprinkling on the streets as a control for dust, and possibly also for flushing gutters prior to main streets being tarmacked. The Bamford engineering group have dated manufacture of the pump at the company's works in Staffordshire to between 1906 and 1915, and photos indeed show that it was present by at least 1914. The original livery is likely to have been different. See FIG. 19 below.

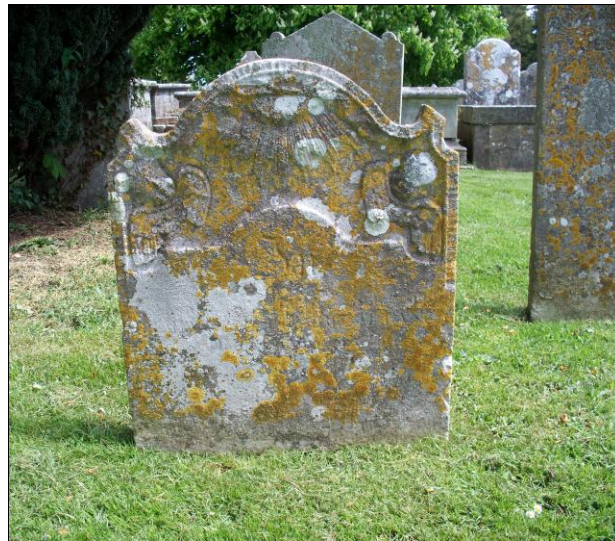
**FIG. 20:** *Churchyard lichens. A colony of lichens viewed on one of St Mary's eighteenth century monuments. The monument above depicts two carved angels beneath a sunburst.*
