Moreton Conservation Area

Appraisal document

Public consultation draft

February 2014

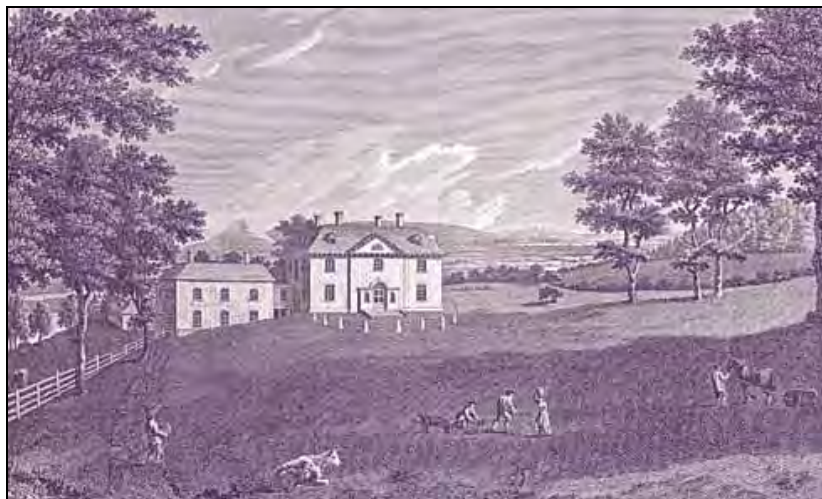
FIG. 1: *Moreton House c.1774. From the first edition of Hutchins. Compare with the view in FIG. 3, which shows little change. Whilst some artistic license must be allowed for, details such as the subdivision of the parkland with post and rail fencing and the generally open (heathland?) backdrop are of some interest in understanding past landscape character and management.*

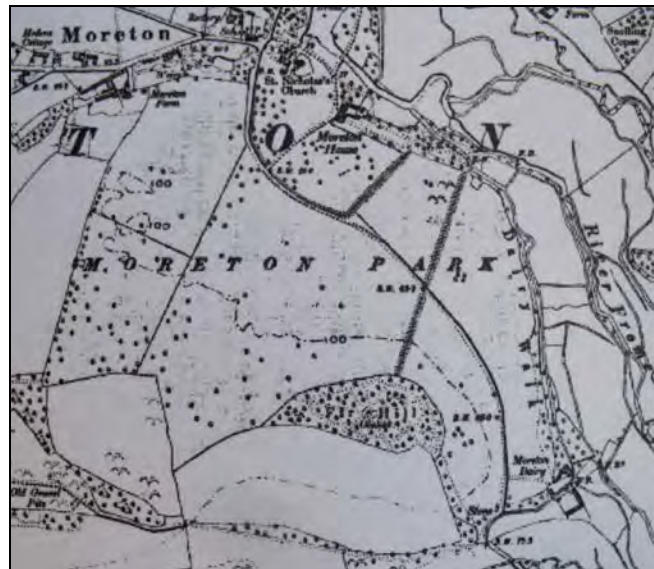
FIG. 2: *Map of the 1890s showing Moreton Park. The inner park, which is included within the conservation area, is clearly demarkated*

The landscape around Moreton House was designed to provide a then fashionable parkland setting, which the shading on old ordnance survey maps suggests was more extensive than at present (see FIG. 2). Both these and the

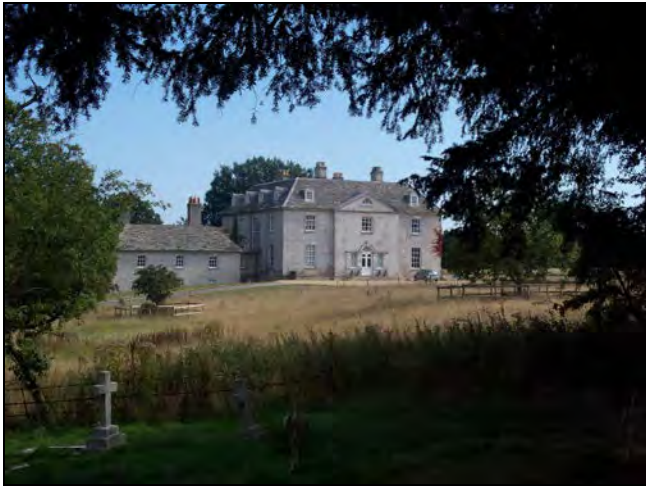
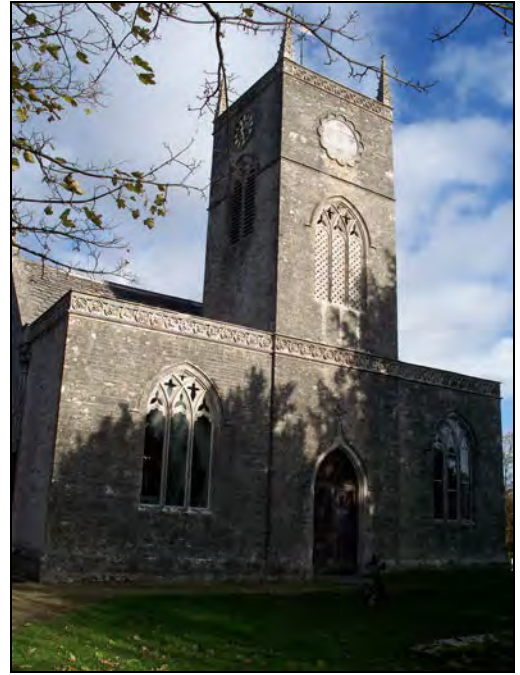
FIG. 3: *Moreton House and the parish church. Key elements of the eighteenth century development of the village.*

There are clear similarities in the forms of the broadly contemporaneous Manor House, Glebe House and Moreton House (see FIGs. 3 and 11), all of which are arranged on a robust square plan which lends a bulky appearance. Most other historic buildings within the conservation area have (or in the case of Manor Farm – FIG. 15 – originally had) a rectangular plan form, with broad front and shallow depth. This provides some with a linear character, with impressions of general mass significantly influenced by height. Here the modest appearance of 2-5 The Street contrasts markedly with that of the more substantial terrace recently constructed to the west.

One of the most interesting views within the conservation area is that of Moreton House from the churchyard (see FIG. 3), a scene which has changed little since the eighteenth century. Glimpses of the house are otherwise allowed from various points along the road passing through the park. Notable views out of the conservation area include that of the obelisk on Fir Hill across the outer parts of Moreton Park. This vista was created during the 1780s to commemorate the life of James Frampton.

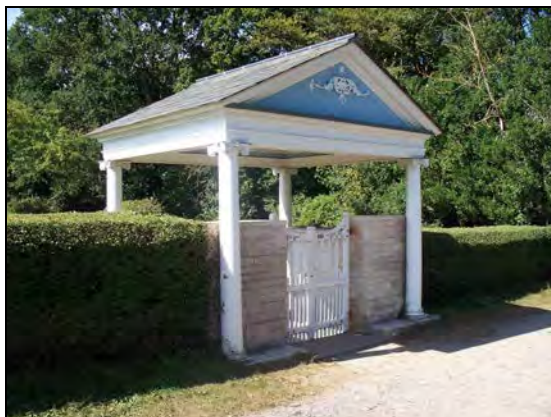
FIG. 4: *Classically styled gate to the new cemetery. Originally constructed c.1800 as entrance to the kitchen garden, and moved here c.1950. The modern brick walls either side incorporate panels taken from the obelisk on Fir Hill to the south of the conservation area.*

Around 1800 a classically styled gate was commissioned to provide an entrance to the kitchen gardens (see FIG. 4 below). This survives in a much reconstructed form as the entrance to the new cemetery, and is one of the more eye catching structures in the conservation area. The extent of heathland within the broader setting of the village continued to be reduced in area through enclosure, and improvement for agricultural use and plantations. The 1839 tithe map shows that at that time, and probably only for a very short period after, a finger of Moreton Heath still extended to fill the gap between Station Road and the lane to Redbridge. This was subsequently occupied by Manor Farm (FIG. 15) and the Kennels. The school (FIG. 14) was present by this time, though its fabric (exposed internally by the hacking of plaster from the walls) shows clear signs of extensive modification since construction. In 1841 the church was enlarged through addition of the north aisle, and the Bakery House and old post office are also likely to date to a similar period.

The burial ground appears to have been established between the wars, with the first burials here dated to the 1930s. Two features distinguish the site: the gate (see FIG. 4 above), which was relocated here around 1950, and the grave of T.E. Lawrence ('Lawrence of Arabia'), whose memorial was carved by his friend, war artist and sculptor Eric Kennington (see FIG. 5 below).

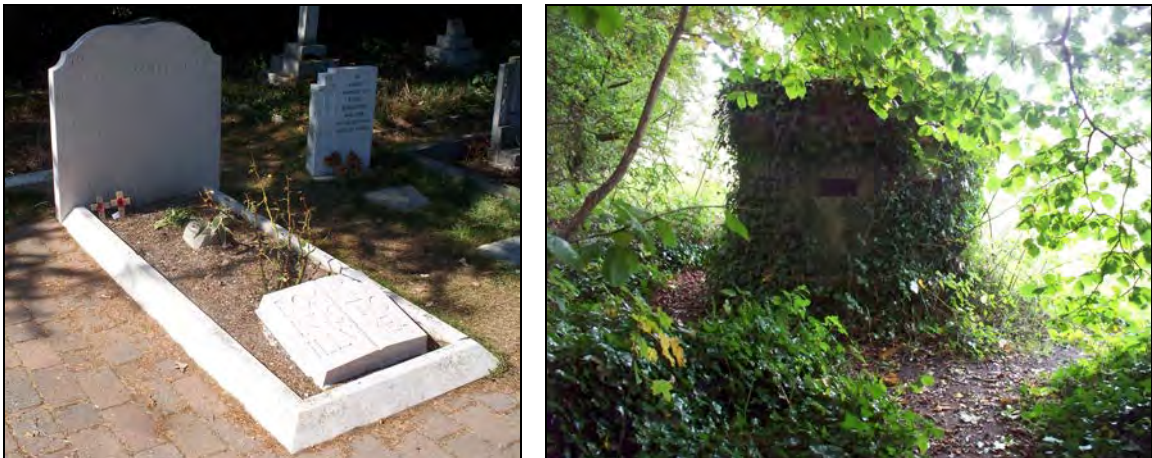
FIG. 5: *Twentieth century interest. Left: gravestone of T.E. Lawrence. Carving by Eric Kennington. Right: World War II pill box overlooking the Frome crossing.*

During the Second World War the river crossing formed part of the Maiden Newton – Poole Harbour 'stop line'. This was designed in 1940 as a secondary defensive line following the Frome valley. Its function was to help repel or hinder a possible German invasion in the event that coastal defences were overrun. The partially overgrown concrete pill box on the north side of the ford (see FIG. 5 above) is one of a number of surviving fortifications of the line installed at the time. Whilst the pill box never saw action, the parish church was damaged by a stray German bomb which destroyed the north aisle and blew out the stained glass windows. The latter were replaced over an extended period by engraved glass panels produced by the artist Sir Laurence Whistler.

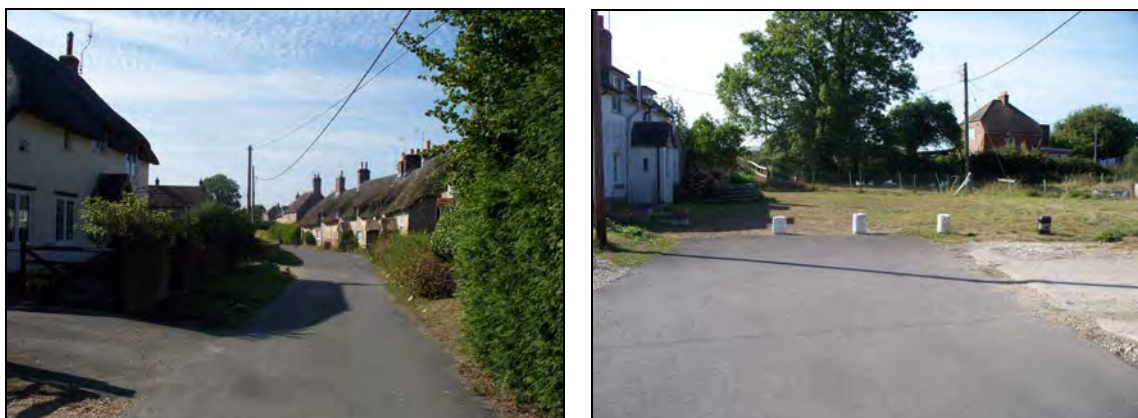
FIG. 6: *The Street. The road curves gently, ending abruptly with a row of plastic barrels and otherwise fizzling out into open space. The road historically continued to Glebe Farm. Note the attractive tree, one of many in the conservation area.*

Most buildings fall within a roughly square 'block', the northern side of which is formed by The Street, the southern and eastern sides Station Road, and west side the access track to Glebe Farm. All four sides historically connected, though The Street now ends abruptly (see FIG. 6 below). In terms of movement, the junction overlooked by the old school provides the key nodal point, however the village otherwise lacks any obvious 'centre' given the fragmented nature of development and street layout, and separation of elements such as the church from the main area of settlement.

Overhead wires: Wires and poles are noticeable around the conservation area, and in particular in views along The Street (see FIG. 6) and Station Road (see FIG. 14). The undergrounding of cables could greatly enhance the appearance of the conservation area.

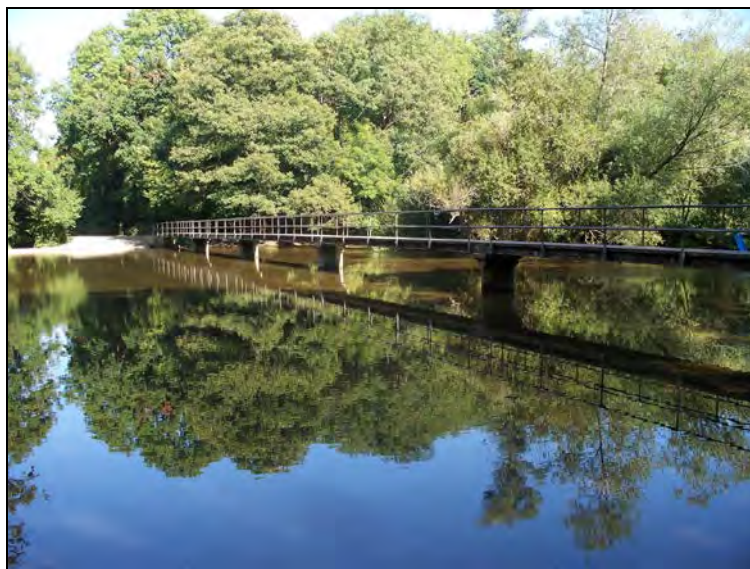
FIG. 8: *The ford and footbridge on the Frome. The pill box shown in FIG. 5 stands on the bank in the undergrowth to the left of shot.*

A particular highlight of the conservation area is the ford across a remarkably broad, but shallow section of the Frome, crossed by a long narrow footbridge. Reflections in the river surface add to the quality of the scene (FIG. 8 below).

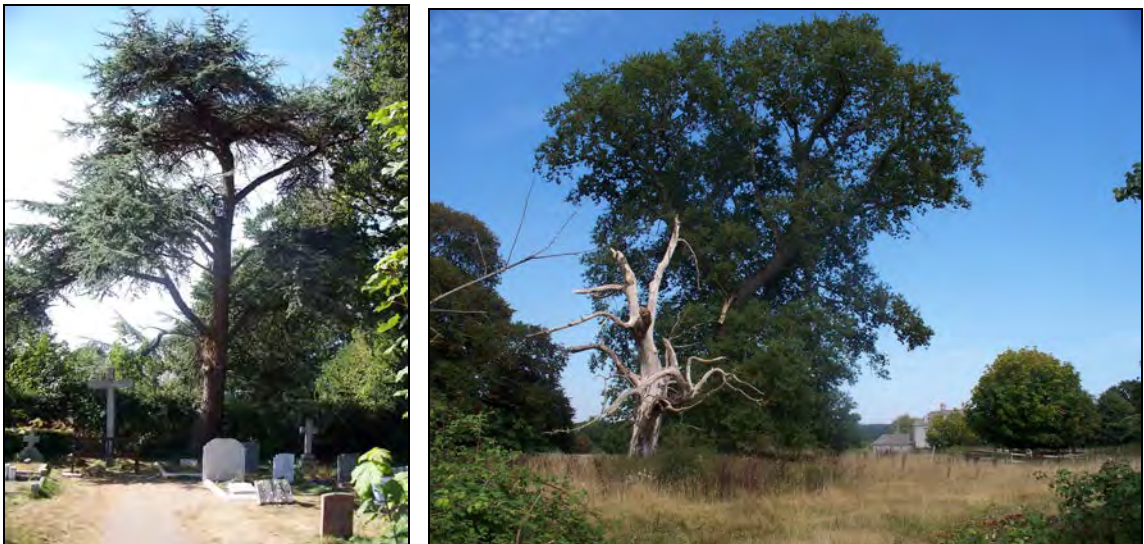
FIG. 9: *Notable trees. Left: pine tree standing behind the gravestone of TE Lawrence. Right: mature oak and standing dead wood in Moreton Park.*

The nineteenth century saw a significant increase in the amount of forestry within the setting of the conservation area, as previously open heathland and common were enclosed, and plantations were established. Trees and woodland now play an important role in forming a backdrop to the village, lining some of the roads into it, and cloaking the river banks. Woodland here merges with planting in the grounds of Moreton House. Trees including oak, ash, chestnut and pine help to characterise the immediate parkland setting to the south and west of Moreton House (see FIG. 9 below). Some of these trees are of considerable age and height, and include some that are evidently dead. Old maps show that trees also occurred to a lesser extent within the outer park in the past (see FIG. 2), though many have since been lost. More ornamental tree planting is visible within Moreton Gardens, and this helps to provide a canopy over the road entering the village from south. Notable trees occurring outside the groups noted above include the large holm oaks and beech trees at the entrance to Glebe House which stand prominently at the fork of Station and Hurst Roads, and a rugged pine which provides an attractive back drop to the gravestone of TE Lawrence (see FIG. 9 below).

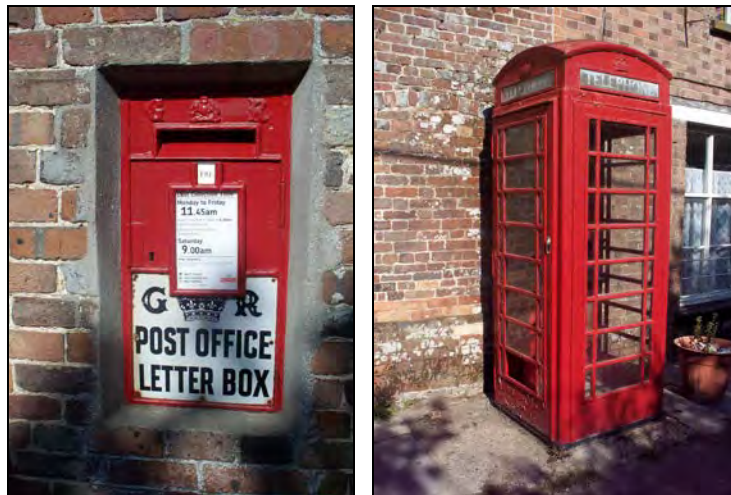
FIG. 10: Letter box and telephone kiosk. Archetypal twentieth century street furniture. The enamel plaque lends interest to the post box, whilst the kiosk would benefit from renovation which might in turn encourage its use.

A red K6 telephone kiosk stands adjacent to the old post office. This is a 'jubilee' model of 1935 design, apparently installed in 1958. Whilst the village does not have a free standing posting box, an interesting George V (1910-36) box with enamel sign is built into the wall of the old post office (see FIG. 10 below). A finger post stands adjacent to the old school, the top and possibly the centre post of which appears to be original (early twentieth century), though the fingers themselves have been replaced.

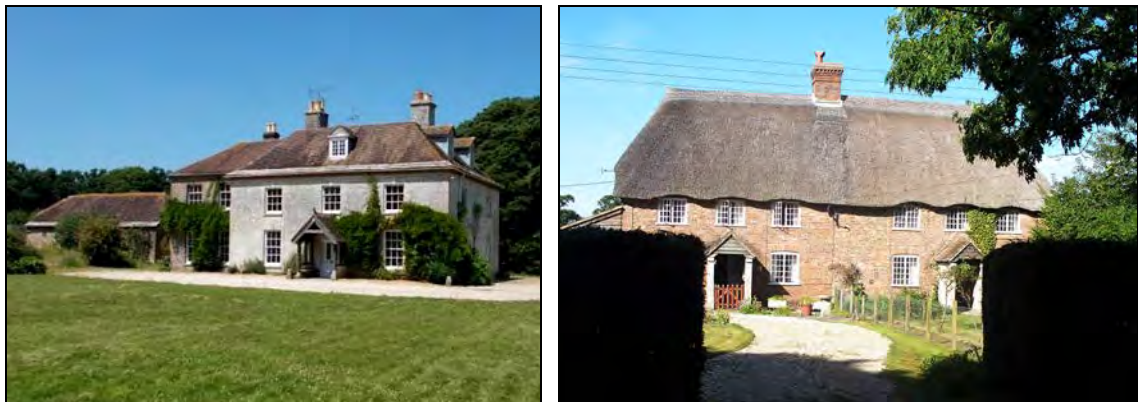
FIG. 11: *Style and status. Left: the Manor House. Right: Manor Farm Cottages. Both properties have a formal composition, though aside from differences in their plan form and size, fixtures and materials help to differentiate status.*

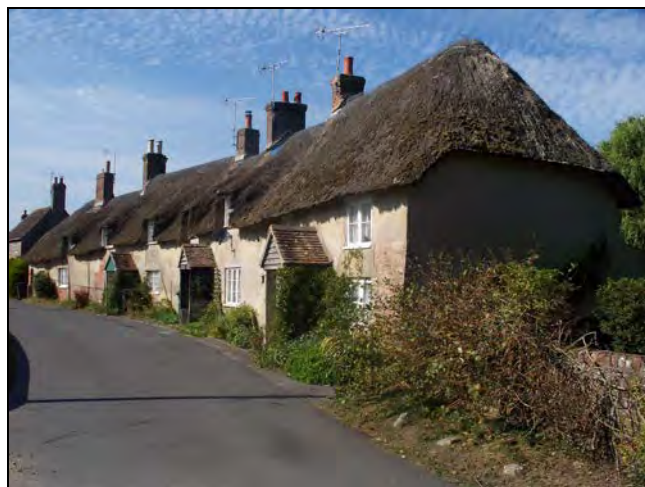
FIG. 13: *Thatched roofs of Nos. 2-5 The Street.*

Thatched roofing is a feature of estate cottages along The Street and is a common roof covering for cottages in the broader area. Wheat straw appears to have been traditionally used in the vicinity. Historic properties within the conservation area have been finished with traditional flush ridges, though the ornamental block ridge of modern Yew Tree Cottage is at odds.

There is an air of slow decline along The Street, many buildings here appearing to be in need of maintenance. Thatch on the roofs of Nos. 2-5 (see FIG. 13) appears heavily worn, and the walls and paintwork of a number of properties along with that of the telephone kiosk, show signs of damage and deterioration. The pill box is in generally good condition though is partially covered with ivy. If left unchecked ivy growth is likely to cause some damage to the brickwork. Buildings elsewhere, where visible, appear to be in generally good repair, though the parish church is missing the arm of its sun dial.

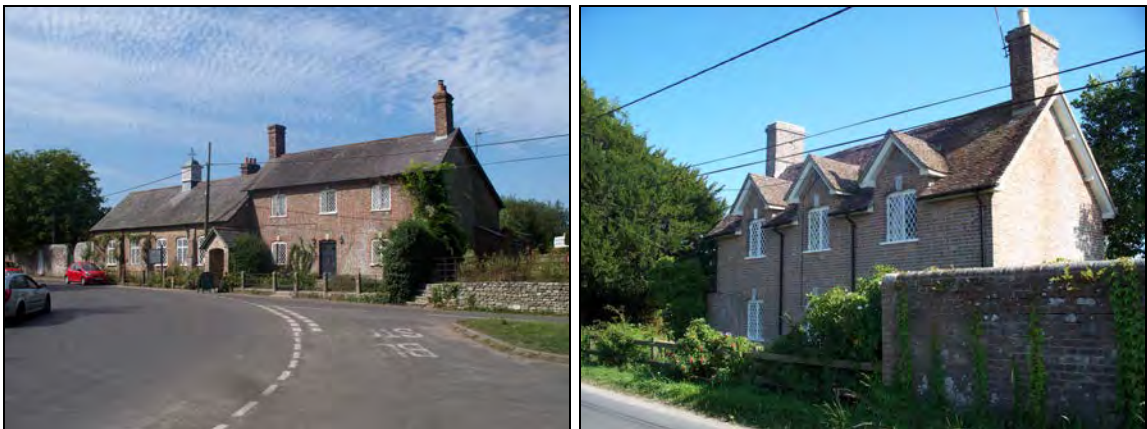
FIG. 14: *The old school and Garden Cottage. These two stylistically similar buildings are the most noticeable to drivers passing through the village due to their roadside positions. Note similarities in form materials and details including pitched roofs, lattice casements and arch designs.*

Due to the roadside positions of the new cemetery gate, old school and Garden Cottage (see FIGs. 4 and 14), simple pitched roofs are particularly noticeable

As is frequently the case, window type tends to vary according to the status and style of the historic buildings concerned. Vertically sliding timber sash windows occur within those buildings in the village of higher status, whilst casements in either steel or timber, occur in those of lower status. The latticework casements of the old school and Garden Cottage are a notable feature of these two stylistically similar buildings (see FIG. 14).

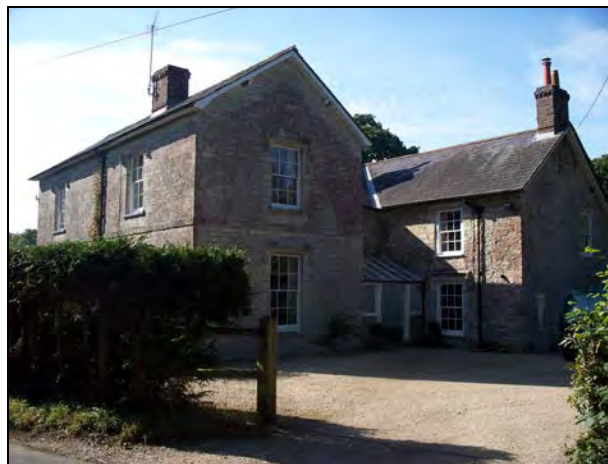
FIG. 15: *Manor Farm. The original house is the range to the right, and probably dates to the early nineteenth century. The range to the left and centre is a large extension probably added later that century. The quality of construction and retention of many original windows is notable. Reflecting the different dates of the two parts of the property, the windows on the older range have exposed sash boxes, whilst those on the later range are recessed.*

Simple segmental brick arches are a repeated feature of brick built cottages, and are embellished with a raised keystone design at the old school, Garden Cottage and used on one of the windows of Bakery House. In common with the church, the windows of Manor Farm (FIG. 15) carry hood moulds which add visual interest.

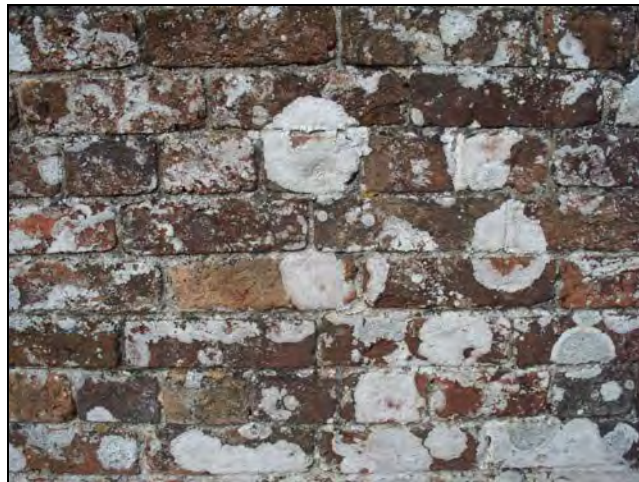
FIG. 16: *Lichen on brickwork along Station Road.*

The visual character of the conservation area is considerably softened by growth of lichens (see FIGs. 12 and 16) which in places entirely covers brick surfaces.
